## MICHIGAN DEPARTMENT OF TRANSPORTATION

STR 11993

## CULVERT SAFETY INSPECTION REPORT

S GIBRALTAR	42.0854 / -83.2057	824263600006B01	Fair Condition(6)	
<b>Feature</b>	<b>Length / Width / Spans</b>	<b>Owner</b>		
BLAKELY DRAIN	34.1 / 42.3 / 1	City: GIBRALTAR(2636)		
<b>Location</b>	<b>Built / Recon. / Paint / Ovly.</b>	<b>TSC</b>	<b>Operational Status</b>	
GIBRALTAR E/JEFFERSON	1992 / / / 1995	Taylor(25)	A Open, no restriction(A)	
<b>Region / County</b>	<b>Material / Design</b>	<b>Last NBI Inspection</b>	<b>Scour Evaluation</b>	
Metro(7) / Wayne(82)	1 Concrete / 19 Culvert	08/02/2023 / HLEP	5 Stable w/in footing

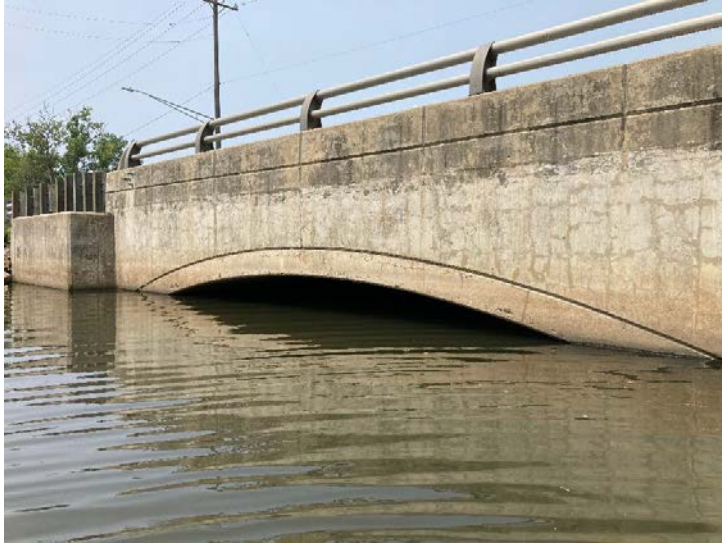
Element Number	Element Name	Total Quantity	Unit	Good CS1	Fair CS2	Poor CS3	Severe CS4
<b>Culvert</b>							
851	Reinf Conc Culvert 3-Sided	42	ft	42 100%	0 0%	0 0%	0 0%
Precast conspan. Water 15" below top of arch. Cracking along the north and south fascia with areas of spalls to steel. 2021 UW report notes light map cracking in culvert soffit with segments 1n and 2n being slightly offset by up to 1".							
861	Culvert Wingwall	4	(EA)	4 100%	0 0%	0 0%	0 0%
CIP wingwalls							
863	Culvert Headwall	2	(EA)	2 100%	0 0%	0 0%	0 0%
CIP headwalls with hairline map cracks

Document Name: IMG\_4641.JPG  
Category: Elevation  
Span Number:  
Comments: South elevation

<b>Recommendation Type</b>	<b>Priority</b>	<b>Description</b>
Super Repair	L	Repair spall with exposed reinforcing steel on fascias of the bridge.

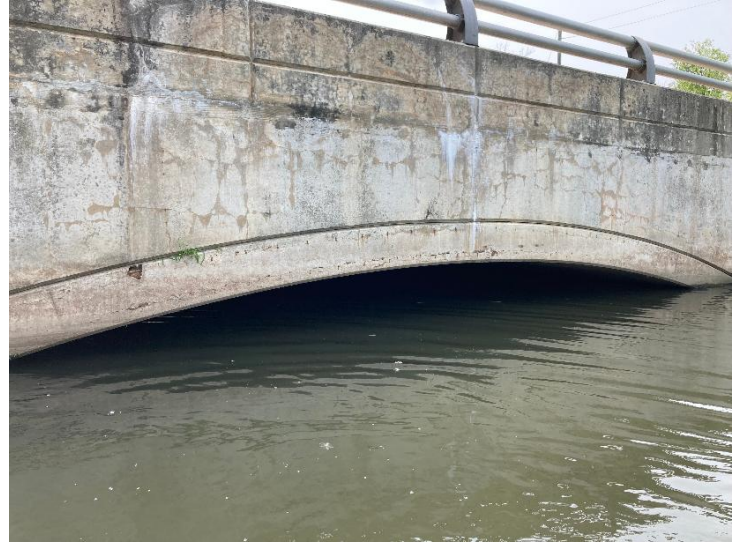
Document Name: IMG\_4645.JPG  
Category: Elevation  
Span Number:  
Comments: North elevation

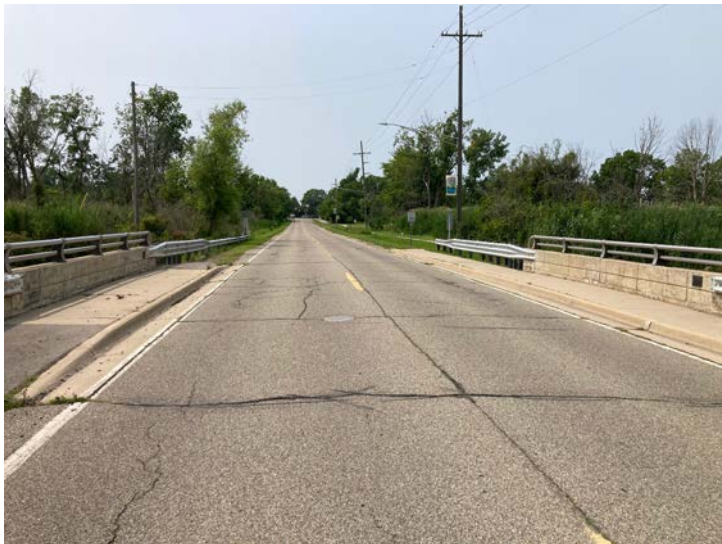
Document Name: IMG\_4632.JPG  
Category: Approach  
Span Number:  
Comments: Looking west through structure

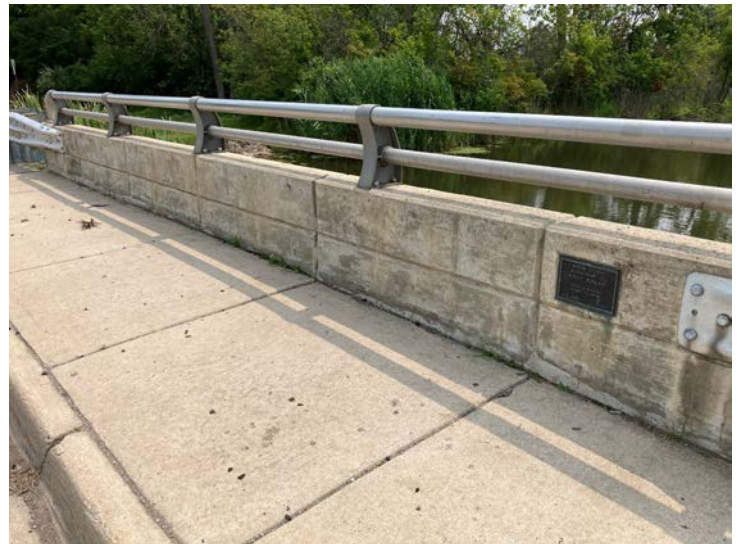
Document Name: IMG\_4635.JPG  
Category: Railing  
Span Number:  
Comments: South rail

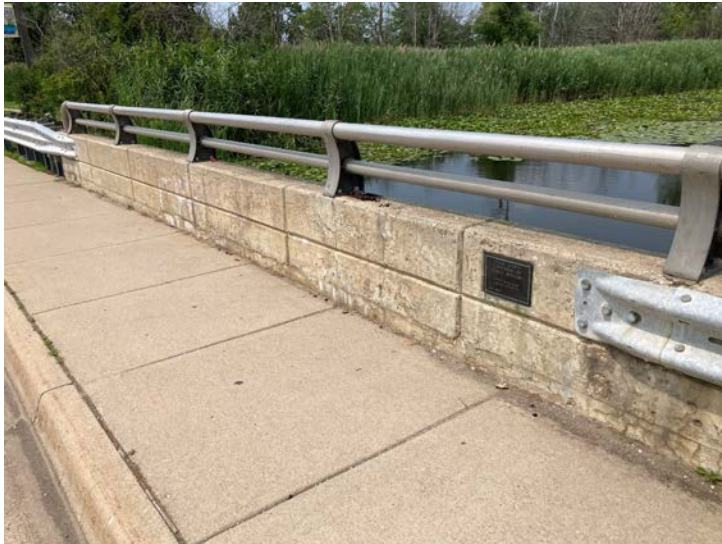
Use east west alignment for roadway. HMA surface with sealed and unsealed cracks. 1 SFT of settlement in WB lane. Heavy leaching map cracks in north rail.

Document Name: IMG\_4638.JPG  
Category: Railing  
Span Number:  
Comments: North rail

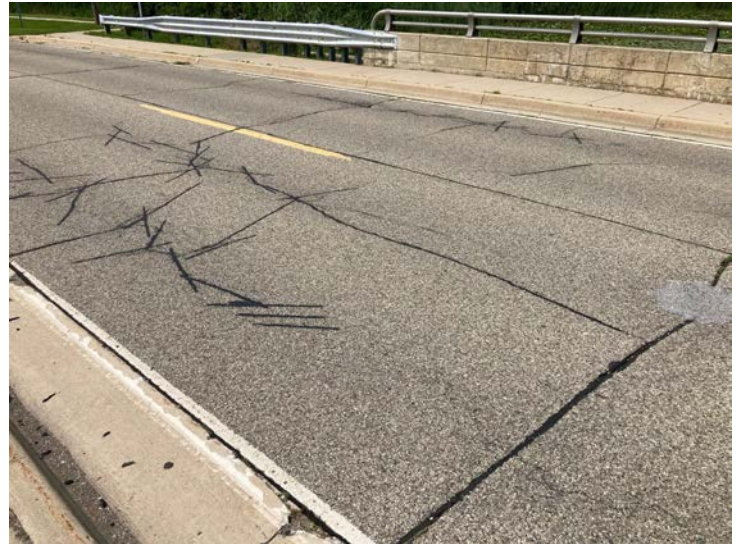
Document Name: IMG\_4633.JPG  
Category: Deck  
Span Number:  
Comments: HMA surface

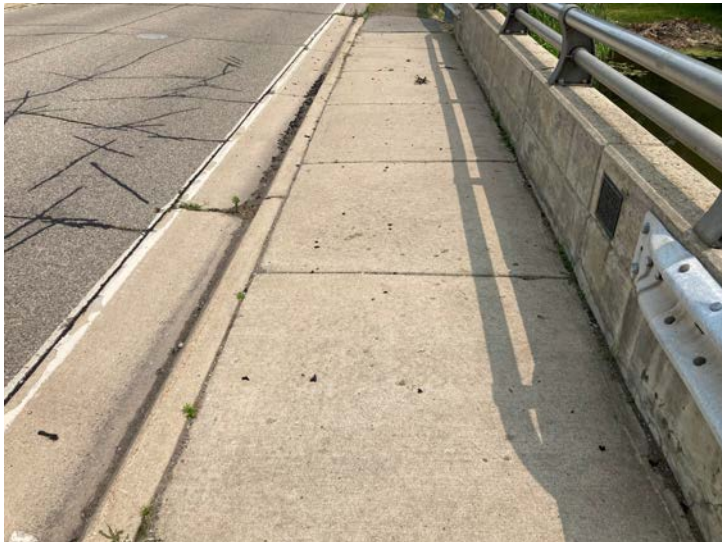
Document Name: IMG\_4634.JPG  
Category: Deck  
Span Number:  
Comments: South sidewalk

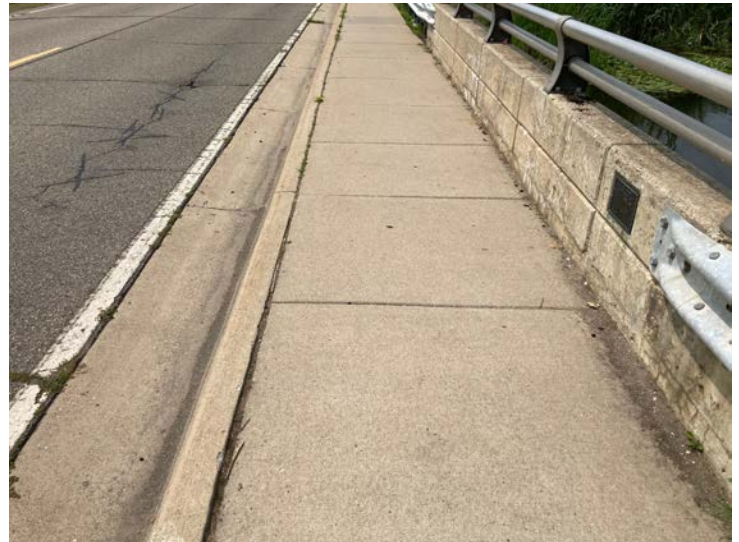
Document Name: IMG\_4637.JPG  
Category: Deck  
Span Number:  
Comments: North sidewalk

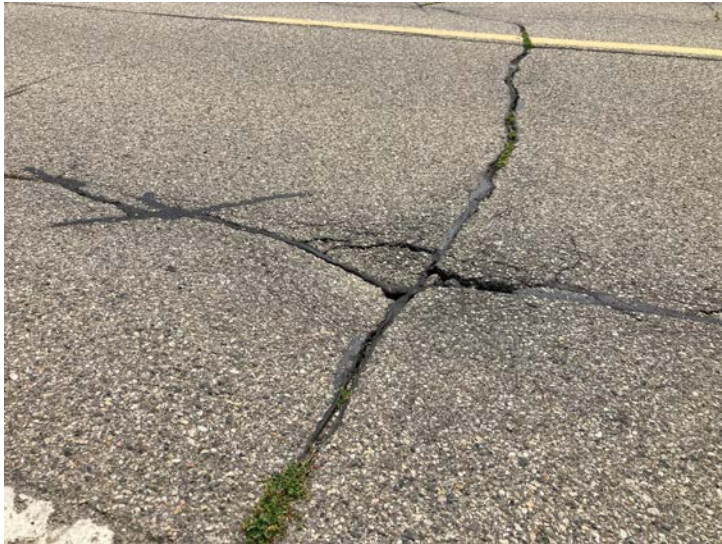
Document Name: IMG\_4640.JPG  
Category: Deck  
Span Number:  
Comments: Settlement in WB lane

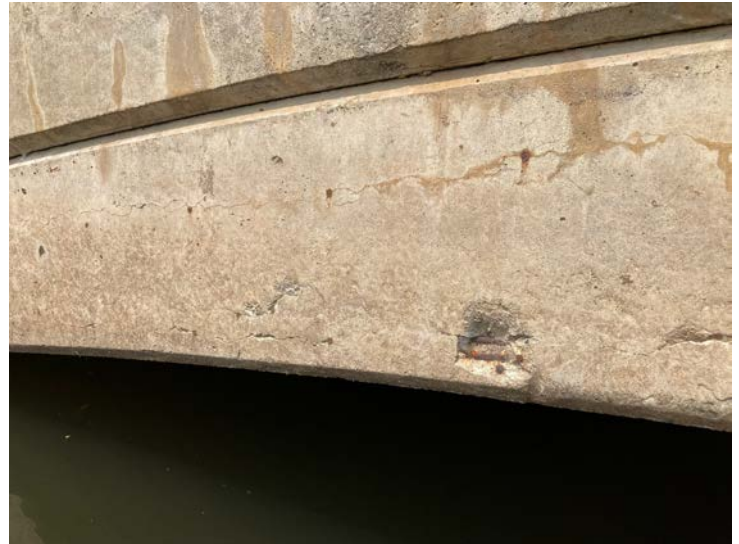
Document Name: IMG\_4642.JPG  
Category: Culvert  
Span Number:  
Comments: STS in fascia

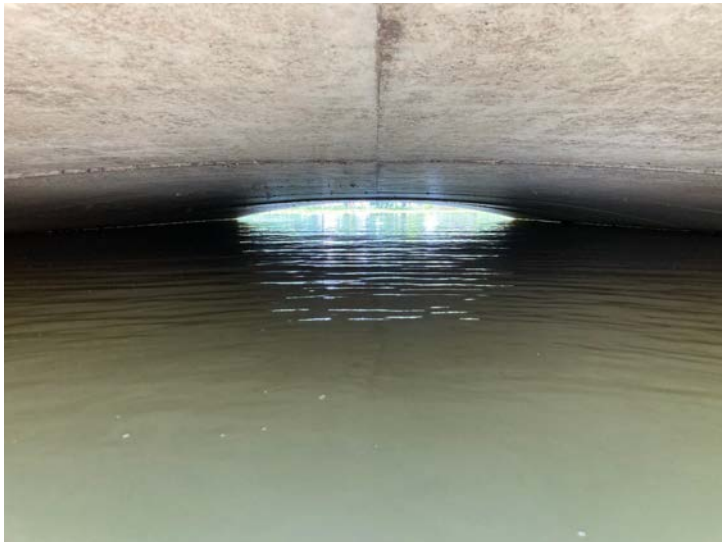
Document Name: IMG\_4643.JPG  
Category: Culvert  
Span Number:  
Comments: Looking north through culvert

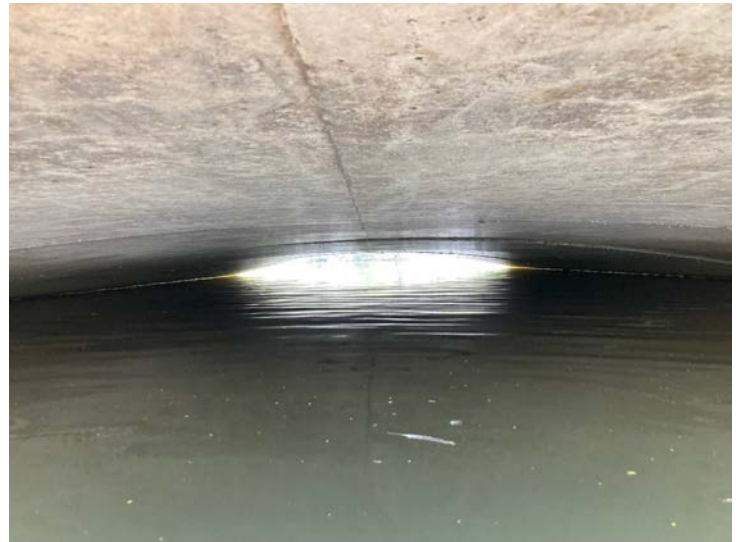
Document Name: IMG\_4646.JPG  
Category: Culvert  
Span Number:  
Comments: Looking south through culvert

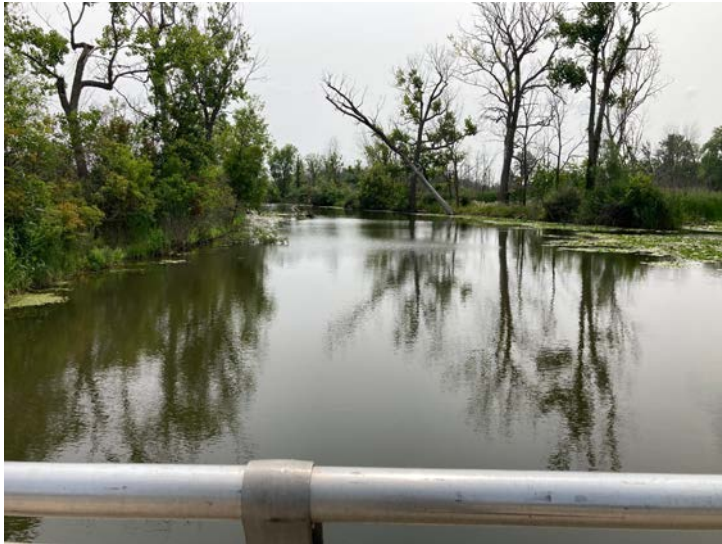
08/19	08/21	08/23	
<b>1. Culvert Rating (SIA-62)</b>	N	7	6	(08/23) (08/21) (08/19)
<b>2. Channel (SIA-61)</b>	7	7	7	Channel banks are heavily vegetated with tall grass and reeds growing between riprap. (08/23) Channel banks are heavily vegetated with tall grass and reeds growing between riprap. (08/21) Bridge constricts waterway approx. 50 feet in NE quad and 30 ft in SW quad. Heavily vegetated with tall grass and reeds growing between riprap. (08/19)
<b>3. Scour</b>	8	8	4	2021 UW inspection report noted the following: West abutment: Vertical footing exposure along the majority of the length of the abutment. no undermining observed. Vertical exposure ranged from 0" to 2'-0". East abutment: Vertical footing exposure along the majority of the length of the abutment. no undermining observed. Vertical exposure ranged from 0" to 1'-0". (08/23) See 2018 UW inspection (08/21) Probed from deck. No scour observed. (08/19)

Document Name: IMG\_4636.JPG  
 Category: Channel  
 Span Number:  
 Comments: South channel

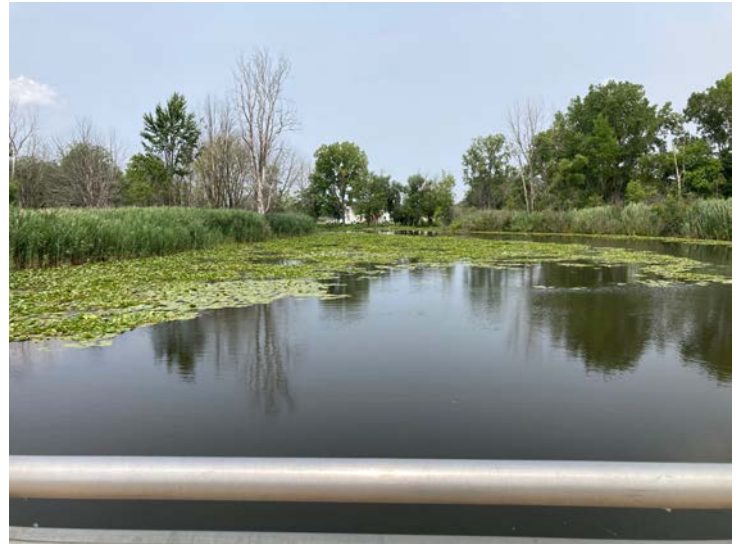
Document Name: IMG\_4639.JPG  
 Category: Channel  
 Span Number:  
 Comments: North channel
