MICHIGAN DEPARTMENT OF TRANSPORTATION

STR 11994 CULVERT SAFETY INSPECTION REPORT

Facility S GIBALTAR	Latitude / Longitude 42.0878 / -83.2	MDOT Structure ID 824263600006B02	Structure Condition Good Condition(7)	
Feature FRANK & POET DRAIN	Length / Width / Spans 27.2 / 42 / 1	Owner City: GIBALTAR(2636)		
Location GIBALTAR E/JEFFERSON	Built / Recon. / Paint / Ovly. 1992 / / /	TSC Taylor(25)	Operational Status A Open, no restriction(A)	
Region / County Metro(7) / Wayne(82)	Material / Design 1 Concrete / 19 Culvert	Last NBI Inspection 08/02/2023 / G3Z9	Scour Evaluation 5 Stable w/in footing

CULVERT INSPECTION G3Z9

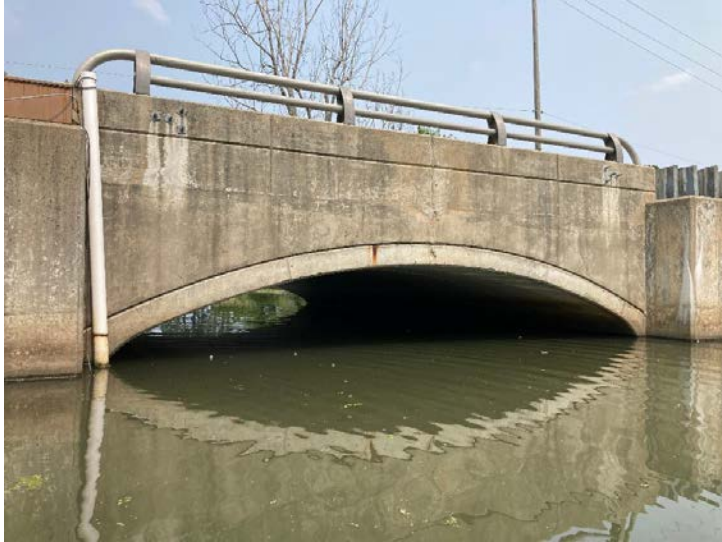
Document Name: IMG_4623.JPG
 Category: Elevation
 Span Number:
 Comments: South elevation

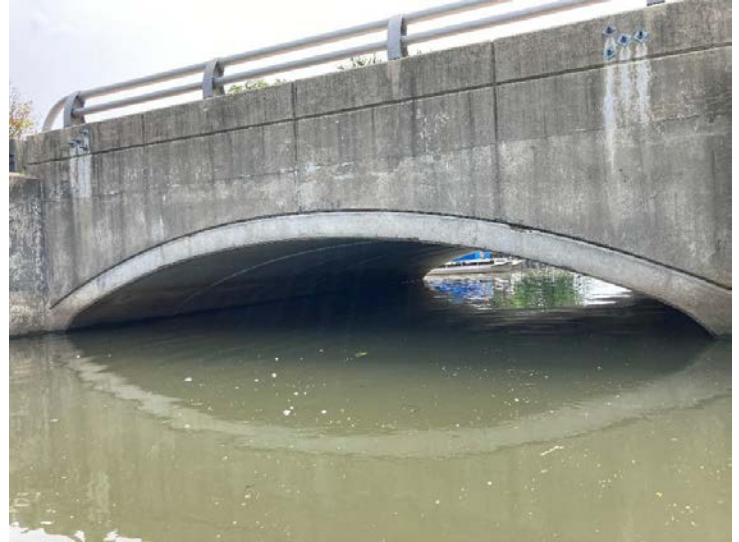
Document Name: IMG_4630.JPG
 Category: Elevation
 Span Number:
 Comments: North elevation

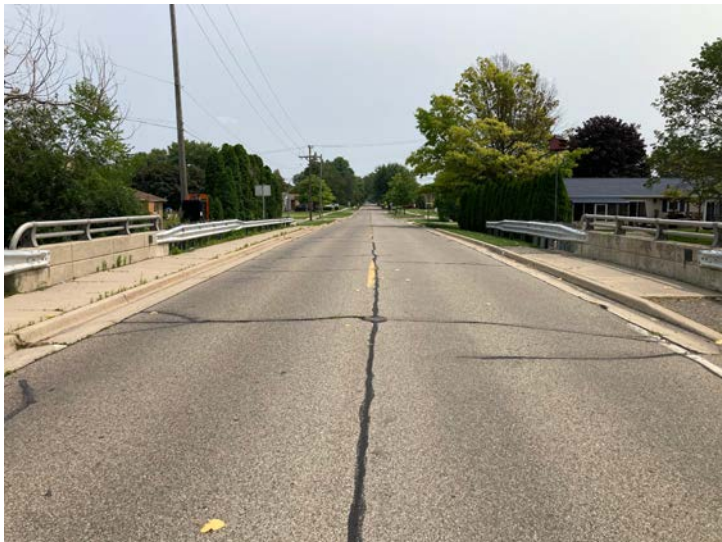
Document Name: IMG_4615.JPG
 Category: Approach
 Span Number:
 Comments: Looking east through structure

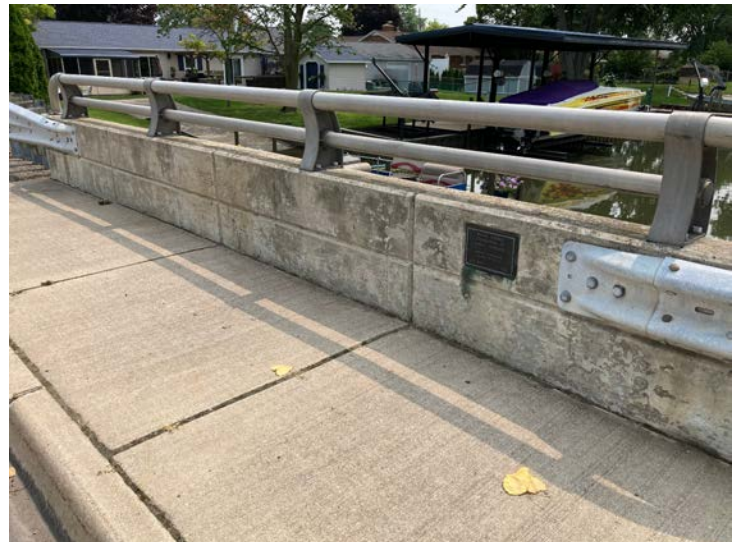
Document Name: IMG_4618.JPG
 Category: Railing
 Span Number:
 Comments: South rail

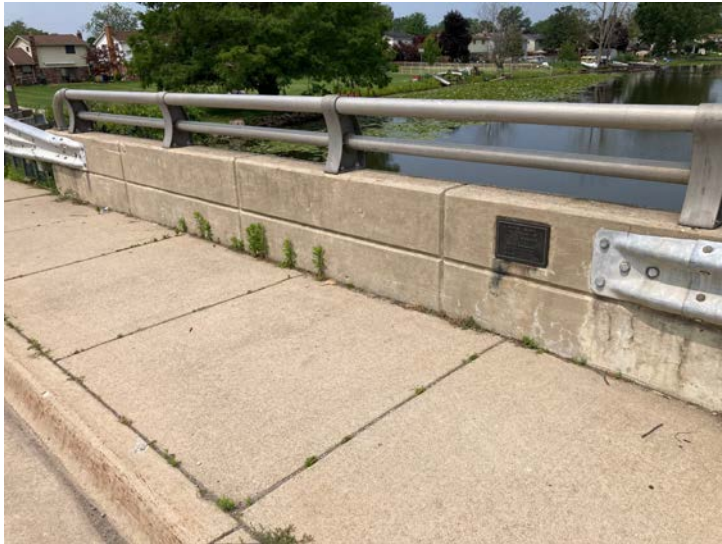
Document Name: IMG_4621.JPG
 Category: Railing
 Span Number:
 Comments: North rail

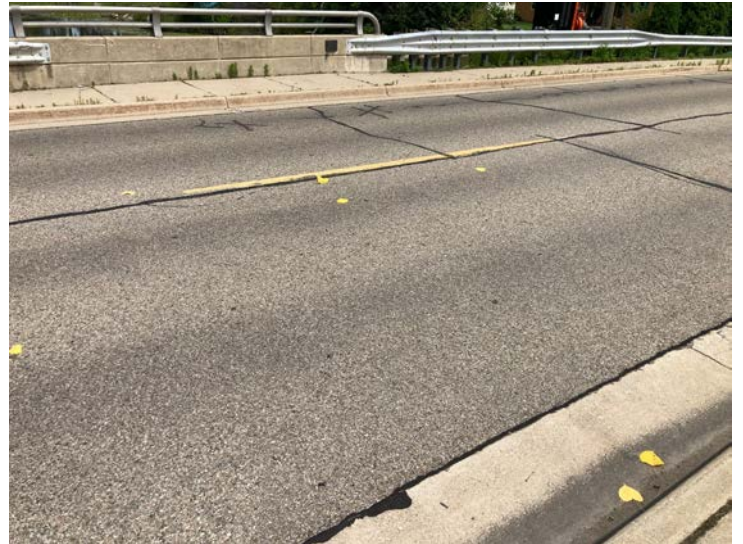
HMA surface with previously sealed cracks. Sidewalk on north and south side of structure.

Document Name: IMG_4616.JPG
 Category: Deck
 Span Number:
 Comments: HMA surface

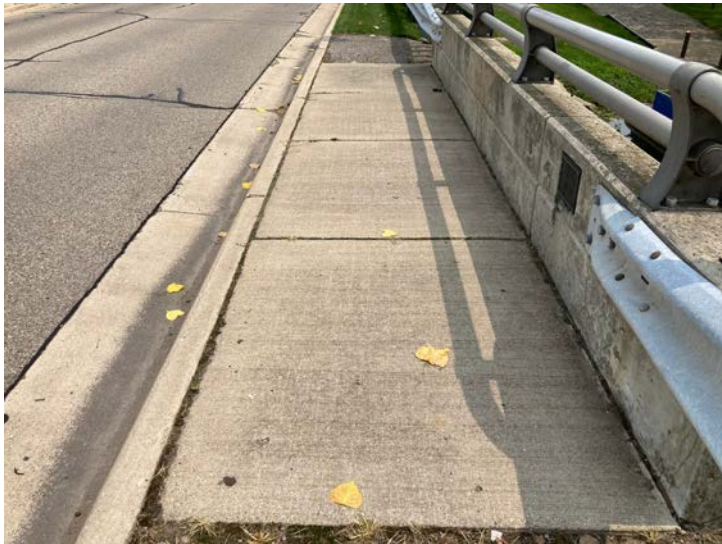
Document Name: IMG_4617.JPG
 Category: Deck
 Span Number:
 Comments: South sidewalk

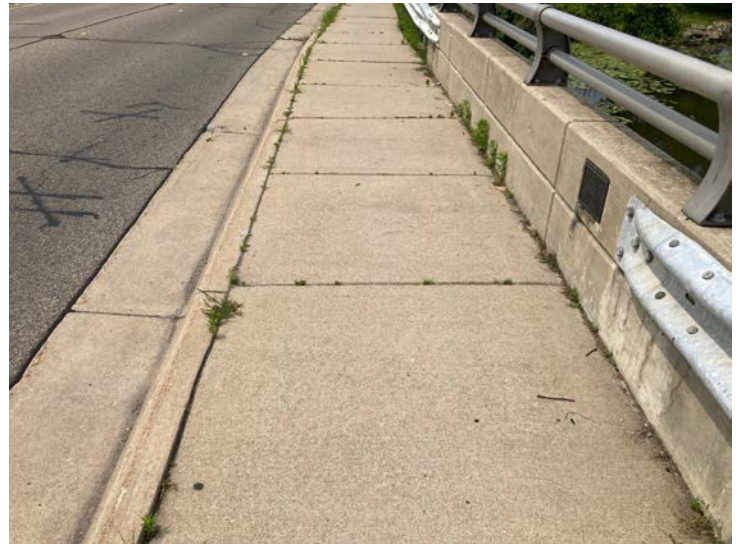
Document Name: IMG_4620.JPG
 Category: Deck
 Span Number:
 Comments: North sidewalk

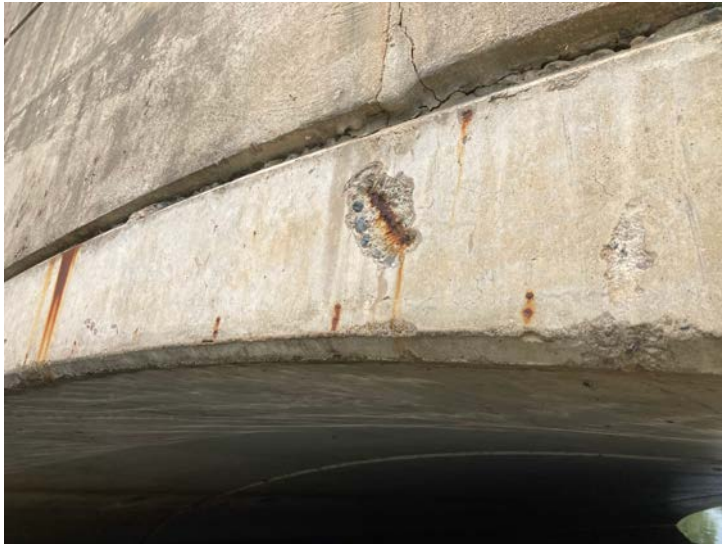
Element Number	Element Name	Total Quantity	Unit	Good CS1	Fair CS2	Poor CS3	Severe CS4
851	Reinf Conc Culvert 3-Sided	42	ft	42 100%	0 0%	0 0%	0 0%
Precast Conspan with concrete headwalls. Both fascias have a 0.5sft STS. HL transverse cracks in segments 1s-4s. Map cracking in segments 5s-7s.							
861	Culvert Wingwall	4	(EA)	4 100%	0 0%	0 0%	0 0%
CIP concrete wingwalls with hairline vertical cracks.							
863	Culvert Headwall	2	(EA)	2 100%	0 0%	0 0%	0 0%
CIP concrete headwalls with concrete railing.

Document Name: IMG_4624.JPG
 Category: Culvert
 Span Number:
 Comments: STS is fascia

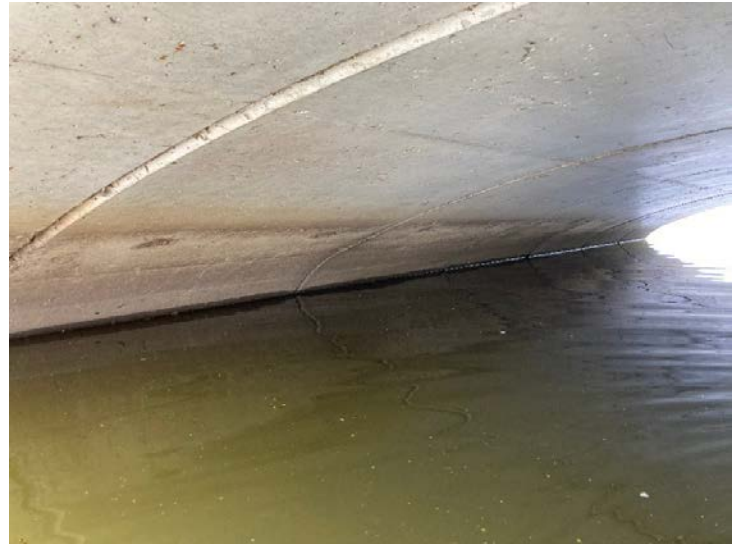
Document Name: IMG_4625.JPG
 Category: Culvert
 Span Number:
 Comments: West abutment

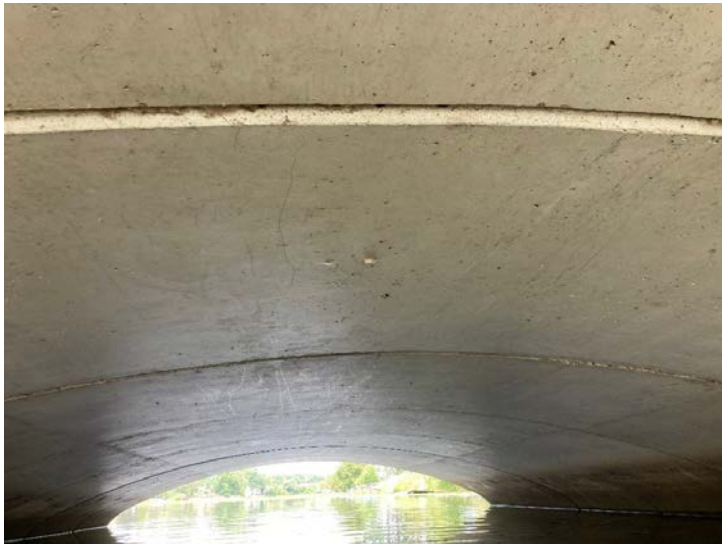
Document Name: IMG_4626.JPG
 Category: Culvert
 Span Number:
 Comments: Soffit

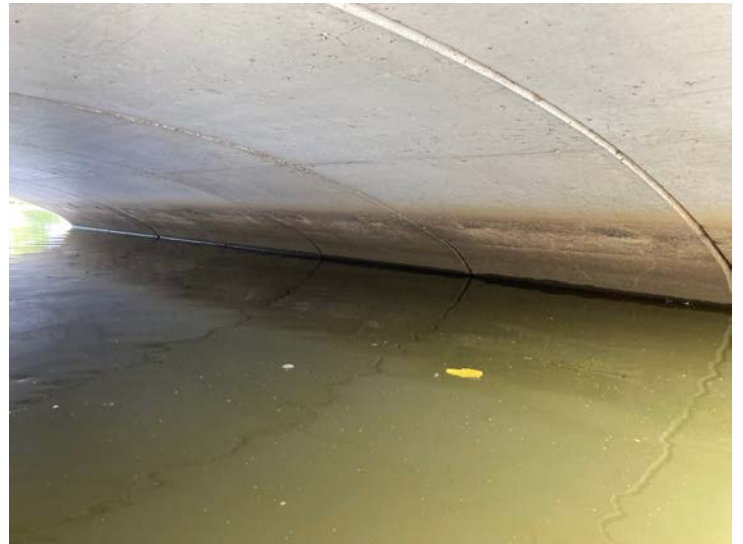
Document Name: IMG_4627.JPG
 Category: Culvert
 Span Number:
 Comments: East abutment

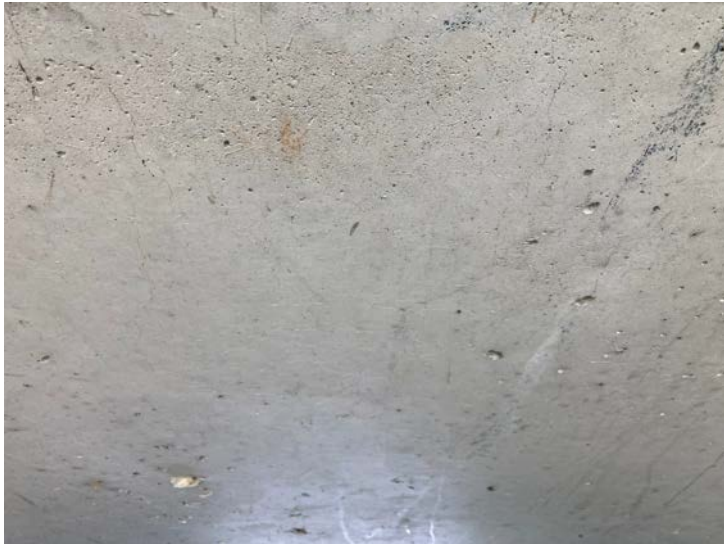
Document Name: IMG_4628.JPG
 Category: Culvert
 Span Number:
 Comments: HL transverse cracks in soffit

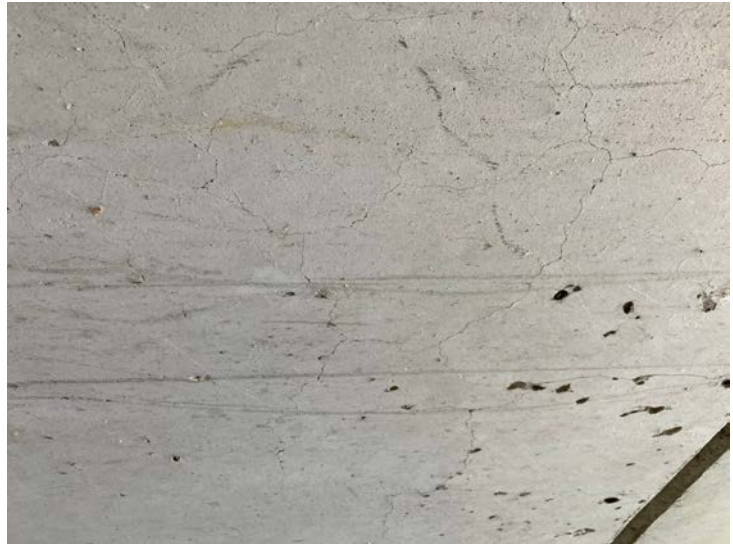
Document Name: IMG_4629.JPG
 Category: Culvert
 Span Number:
 Comments: HL map cracks in soffit

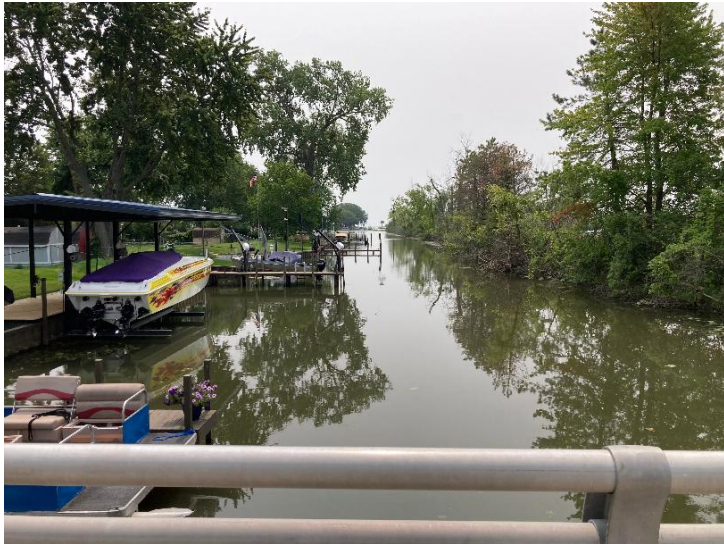
08/19	08/21	08/23	
1. Culvert Rating (SIA-62)	N	8	7	(08/23) (08/21) (08/19)
2. Channel (SIA-61)	6	6	6	Slow flow. NE, NW, and SW quadrants were well vegetated with concrete slabs. The SE quadrant was protected with cut concrete slabs and private docks. (08/23) NE, NW, and SW quadrants were well vegetated with concrete slabs. The SE quadrant was protected with cut concrete slabs and private docks. (08/21) Bridge constricts waterway by approximately 40 feet. NE, NW, and SW quadrants were well vegetated with tall grass and reeds around the concrete slabs. The SE quadrant was protected with cut concrete slabs and private docks. (08/19)

Document Name: IMG_4619.JPG
 Category: Channel
 Span Number:
 Comments: South channel

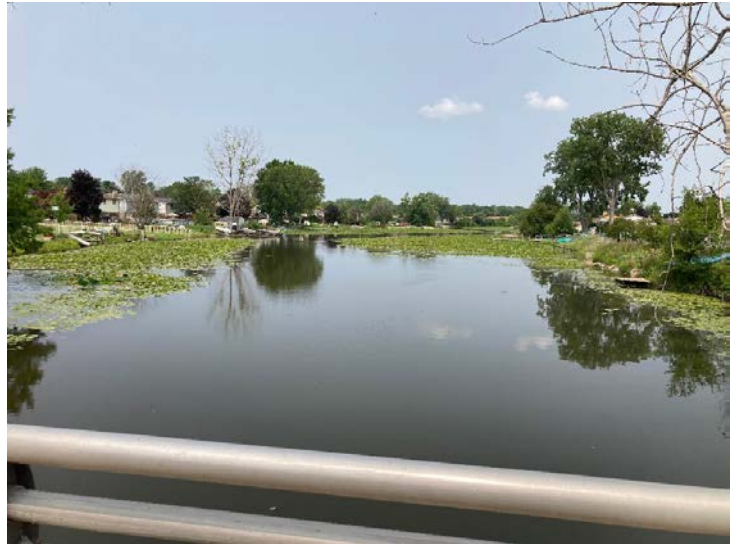
Document Name: IMG_4622.JPG
 Category: Channel
 Span Number:
 Comments: North channel
