MICHIGAN DEPARTMENT OF TRANSPORTATION

STR 11995

BRIDGE SAFETY INSPECTION REPORT

Facility STOEFLER ROAD	Latitude / Longitude 42.0904 / -83.1931	MDOT Structure ID 824263600006B03	Structure Condition Fair Condition(5)
Feature W GIBRALTAR WATERWAY	Length / Width / Spans 26.9 / 37.7 / 1	Owner City: GIBRALTAR(2636)	
Location GIBRALTAR E/S GIBRALTAR	Built / Recon. / Paint / Ovly. 1992 / / /	TSC Taylor(25)	Operational Status A Open, no restriction(A)
Region / County Metro(7) / Wayne(82)	Material / Design 5 Prestressed Concrete / 05 Box Bm/Gird- Multiple	Last NBI Inspection 08/02/2023 / 1J4U	Scour Evaluation 5 Stable w/in footing

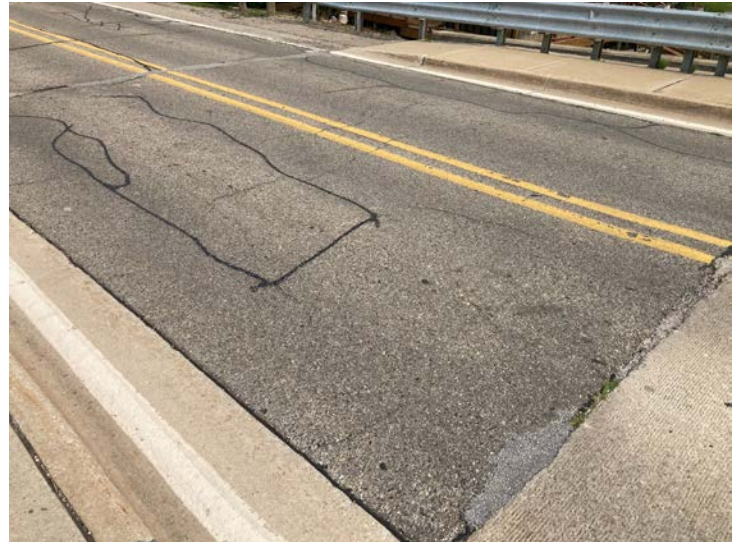
18. Approach Pavement	6	6	6	HMA with ruts in wheel lines. Sealed cracks in both approaches. Estimate 1/2" of settlement in approaches. (08/23) HMA with ruts in wheel lines. Sealed cracks in both approaches. Estimate 1/2" to 1" of settlement in approaches. (08/21) Minor transverse and longitudinal cracks, 90% are sealed. (08/19)

Document Name: IMG_4532.JPG
 Category: Approach
 Span Number:
 Comments: West approach

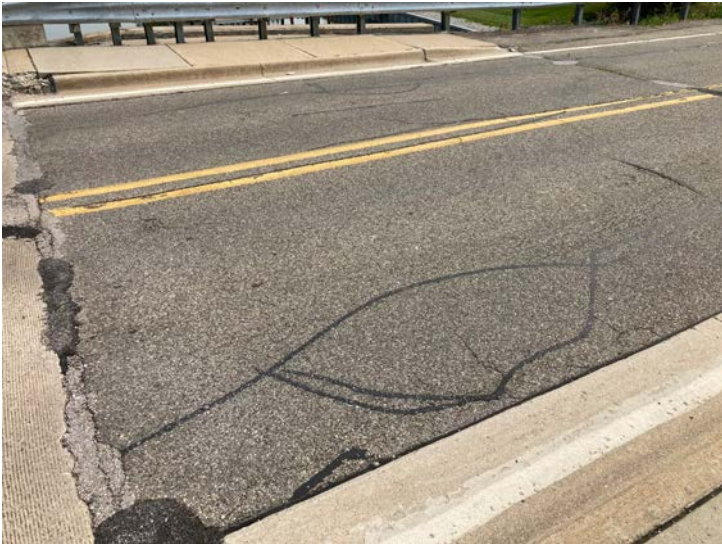
Document Name: IMG_4536.JPG
 Category: Approach
 Span Number:
 Comments: East approach

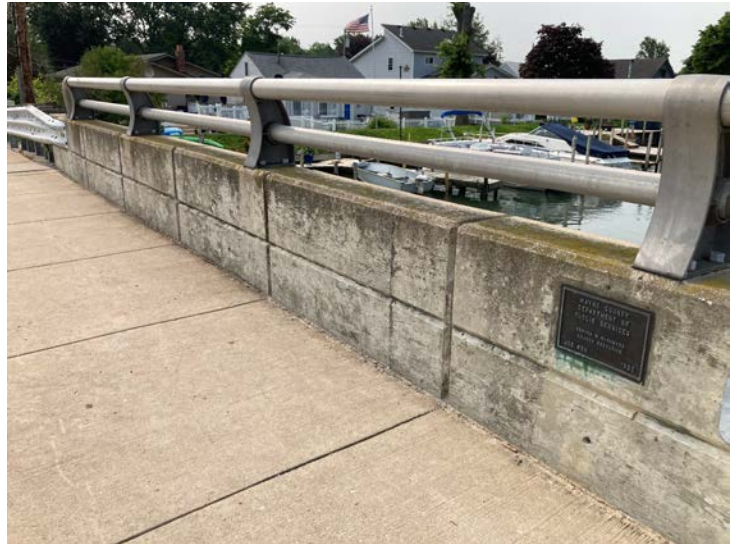
4. Railings	7	7	7	Solid concrete parapet with 2 tubes. Hairline vertical cracks on both parapets. (08/23) Hairline vertical cracks on both parapets. (08/21) Hairline vertical cracks on both parapets. (08/19)

Document Name: IMG_4538.JPG
 Category: Railing
 Span Number:
 Comments: South rail

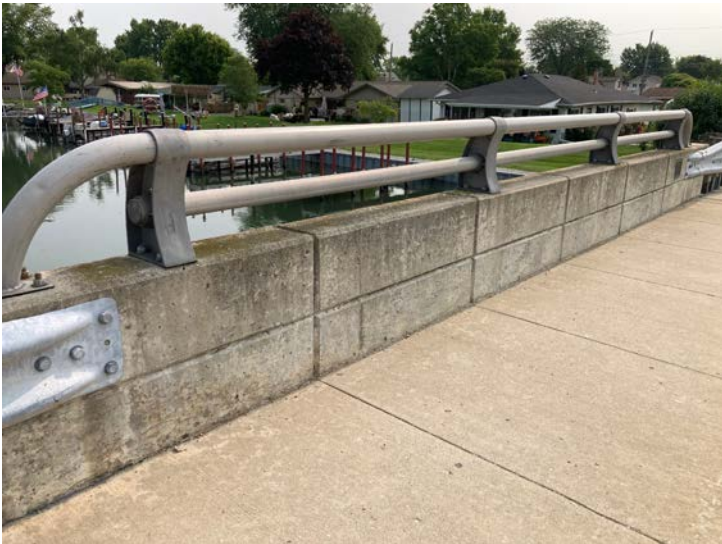
Document Name: IMG_4541.JPG
 Category: Railing
 Span Number:
 Comments: North rail

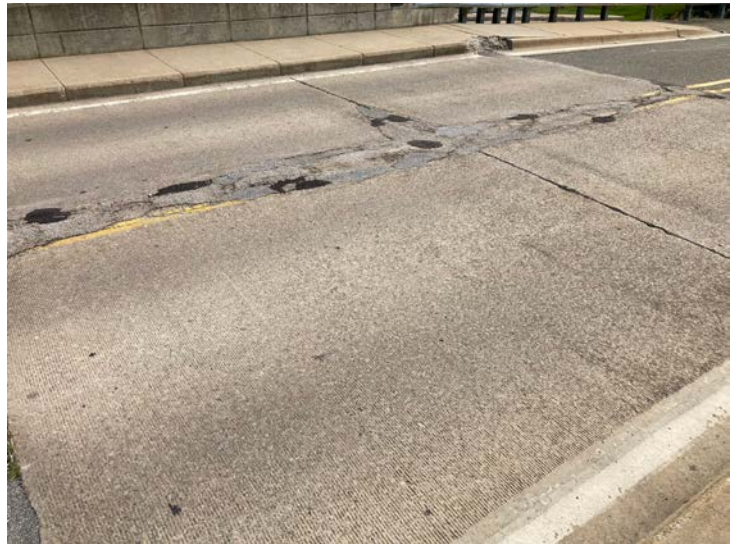
08/19	08/21	08/23	
1. Surface (SIA-58A)	7	5	5	Concrete surface. Along centerline, 12"-18" wide HMA patch full length of bridge. 4'x2' HMA patch in WB. 4' x 2" at eat reference line. (08/23) Concrete surface. Along centerline, 12"-18" wide HMA patch full length of bridge. 4'x2' HMA patch in WB. (08/21) Spalls 2 to 6 in wide x 2 in deep with asphalt patch along centerline (08/19)

Document Name: IMG_4534.JPG
 Category: Deck
 Span Number:
 Comments: Deck surface

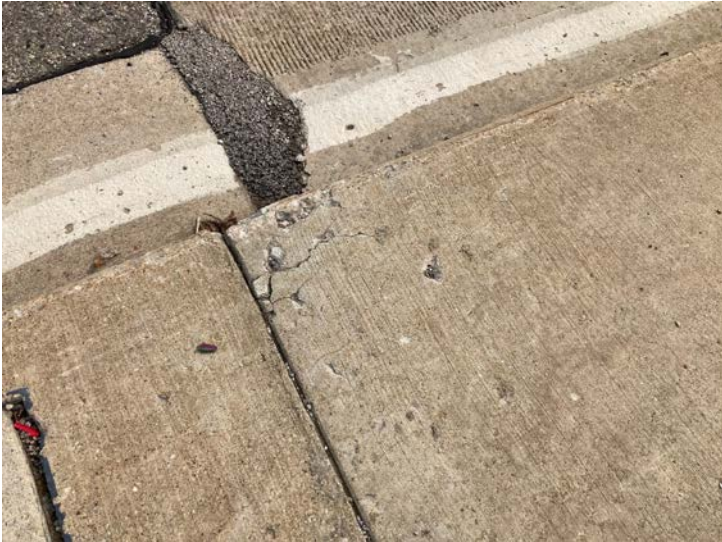
5. Sidewalks or Curbs	6	6	6	Area of spalling on the north curb at the West Abutment (48 in x 6 in x 3 in pen). Area of cracking and spalling at the NE curb (36 in x 6 in x 1.5 in pen). Incipient spall in corner of SW sidewalk. (08/23) Area of spalling on the north curb at the West Abutment (24 in x 6 in x 3 in pen). Area of cracking and spalling at the NE curb (36 in x 6 in x 1.5 in pen). (08/21) Area of spalling on the north curb at the West Abutment (12 in x 6 in x 3 in pen). NE end of sidewalk/drainage swale completely separated from rest of structure with a 3 in gap. Area of cracking and spalling at the NE curb (18 in x 6 in x 1.5 in pen). Settlement at all 4 corners of sidewalks/drainage swales as follows: NE - 1.5 in; NW - 1.0 in; SE - 1.5 in; SW - 1.5 in. (08/19)

Document Name: IMG_4543.JPG
 Category: Deck
 Span Number:
 Comments: Incipient spall, SW sidewalk corner

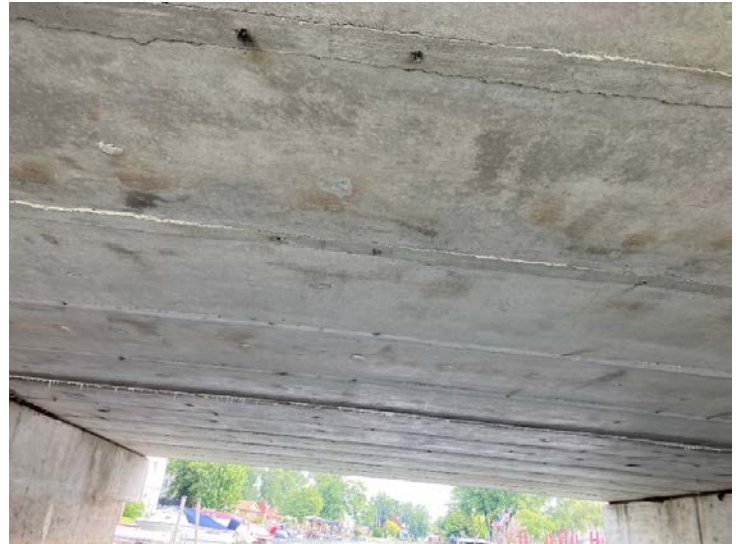
9. Stringer (SIA-59)	7	6	6	12 (EA) Side by side box beams. Joint between beams 6S and 7S is leaking with efflorescence. Beam 7S has hairline longitudinal leaching cracks along full length of beam. Efflorescence noted at PT pocket in north fascia, east end. (08/23) Side by side box beams. Joint between beams 6S and 7S is leaking with efflorescence. Beam 7S has hairline longitudinal leaching cracks along full length of beam. (08/21) Longitudinal joint between box beams 6 and 7 from the north exhibited light water staining and efflorescence for the whole span length. The longitudinal joints between the beams had concrete patches along the entire span length with random areas of chipping and concrete loss over 10% of the total area. (08/19)

Document Name: IMG_4547.JPG
 Category: Superstructure
 Span Number:
 Comments: Beams

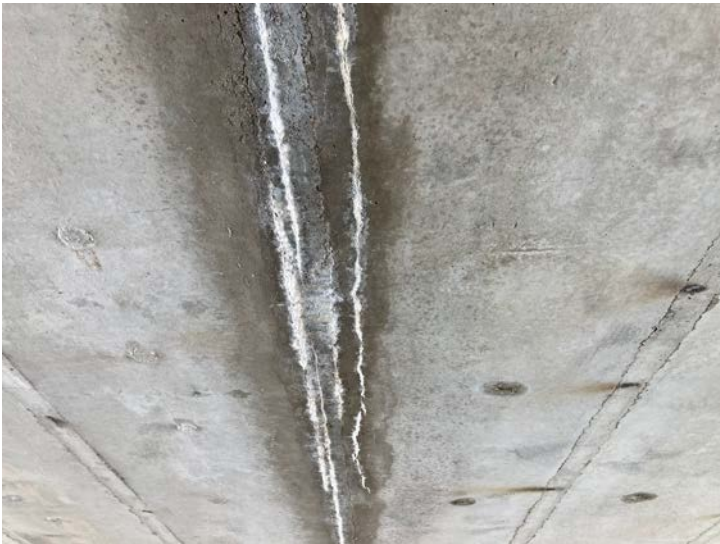
10. Paint (SIA-59A)	N	N	N	(08/23) (08/21) (08/19)
11. Section Loss	N	N	3	Longitudinal crack in beam 7S, no rust. (08/23) (08/21) (08/19)
12. Bearings	7	7	7	Damaged and displaced pad under beams 4 and 5 at west abutment. (08/23) Damaged and displaced pad under beams 4 and 5 at west abutment. (08/21) Damaged and displaced pad under beams 4 and 5 at west abutment. (08/19)

Document Name: IMG_4548.JPG
 Category: Superstructure
 Span Number:
 Comments: Leaching crack, beam 7s

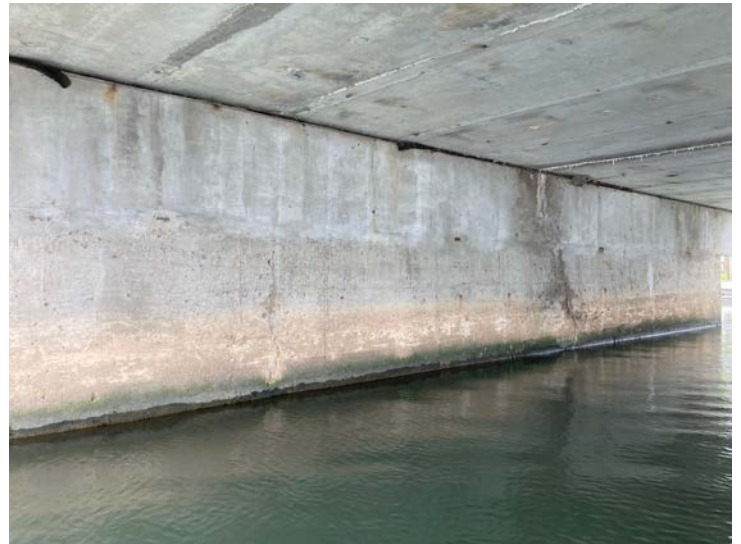
13. Abutments (SIA-60)	6	6	6	<p>Rust on all steel sheet pile wingwalls near the ground line. Concrete surfaces of the abutments have shallow 6" STS.</p> <p>West - Crack in top face of SW wingwall cap at east end measuring 3/4 in. wide by 12 in. long with failed epoxy repair. (8) vertical hairline to 1/16 in. cracks with rust staining were observed extending from the waterline through the abutment cap. (2) vertical hairline to 1/16 in cracks with rust staining were observed extending from the bottom of the abutment cap to the waterline, with one extending to streambed.</p> <p>East - Two cracks in the top face of the NE wingwall cap at the west end measuring 15 in. long by 1/8 in wide. (3) vertical hairline to 1/16 in cracks with rust staining were observed at the 1/4 and mid points of the bridge extending from the channel bottom through the abutment cap. (2) voids near the north end: 2' Long x 2" High x 2" Deep and 1.5' Long x 1' High x 1" Deep. (08/23)</p> <p>Rust on all steel sheet pile wingwalls near the ground line. Concrete surfaces of the abutments have shallow 6" STS.</p> <p>West - Crack in top face of SW wingwall cap at east end measuring 3/4 in. wide by 12 in. long with failed epoxy repair. (8) vertical hairline to 1/16 in. cracks with rust staining were observed extending from the waterline through the abutment cap. (2) vertical hairline to 1/16 in cracks with rust staining were observed extending from the bottom of the abutment cap to the waterline, with one extending to streambed.</p> <p>East - Two cracks in the top face of the NE wingwall cap at the west end measuring 15 in. long by 1/8 in wide. (3) vertical hairline to 1/16 in cracks with rust staining were observed at the 1/4 and mid points of the bridge extending from the channel bottom through the abutment cap. (2) voids near the north end: 2' Long x 2" High x 2" Deep and 1.5' Long x 1' High x 1" Deep. (08/21)</p> <p>Minor to moderate corrosion and delamination of all steel sheet pile wingwalls near the ground line with up to 1/4 in. pen. Concrete surfaces of the abutments below water were typically rough but sound and were smooth and sound above water with random areas up to 6 in. diameter of insufficient concrete cover and exposed reinforcing steel. The channel bottom in the vicinity of the abutments consisted of sand, gravel, and concrete debris up to 24 in. diameter with 1 in. probe rod pen.</p> <p>West - Crack in top face of SW wingwall cap at east end measuring 3/4 in. wide by 12 in. long with failed epoxy repair; indicative of steel sheet pile wingwall deflecting outward. (8) vertical hairline to 1/16 in. cracks with rust staining were observed extending from the waterline through the abutment cap. (2) vertical hairline to 1/16 in cracks with rust staining were observed extending from the bottom of the abutment cap to the waterline, with one extending to streambed.</p> <p>East - Two cracks in the top face of the NE wingwall cap at the west end measuring 15 in. long by 1/8 in wide; indicative of steel sheet pile wingwall deflecting outward. (3) vertical hairline to 1/16 in cracks with rust staining were observed at the 1/4 and mid points of the bridge extending from the channel bottom through the abutment cap. (2) voids near the north end: 2' Long x 2" High x 2" Deep and 1.5' Long x 1' High x 1" Deep. (08/19)</p>

Document Name: IMG_4545.JPG
 Category: Substructure
 Span Number:
 Comments: West abutment

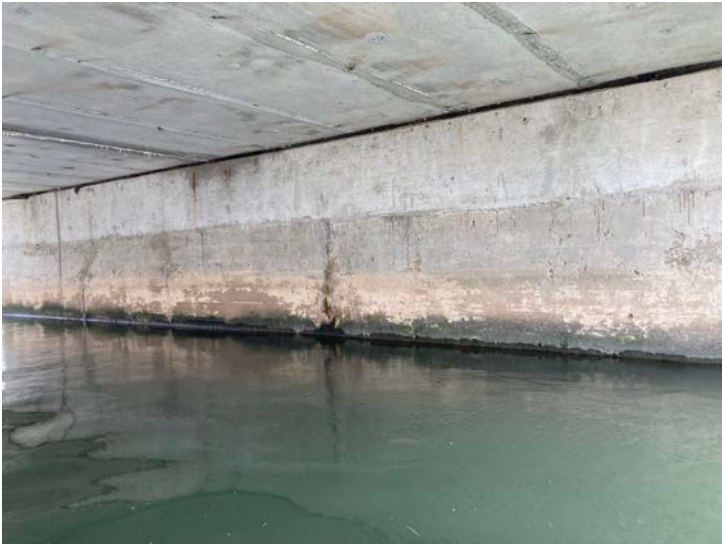
Document Name: IMG_4546.JPG
 Category: Substructure
 Span Number:
 Comments: East abutment

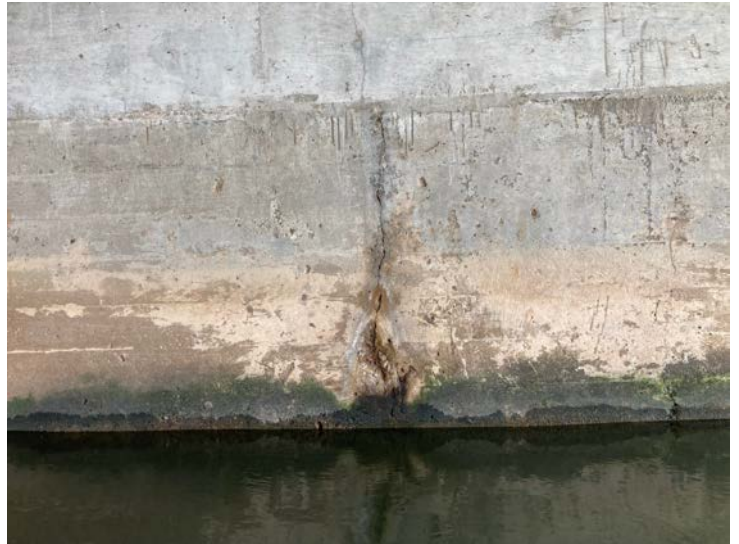
Document Name: IMG_4549.JPG
 Category: Substructure
 Span Number:
 Comments: Vertical crack in abutment, typical
