MICHIGAN DEPARTMENT OF TRANSPORTATION

STR 11996

BRIDGE SAFETY INSPECTION REPORT

<b>Facility</b> STOEFLET ROAD	<b>Latitude / Longitude</b> 42.09 / -83.1914	<b>MDOT Structure ID</b> 824263600006B04	<b>Structure Condition</b> Fair Condition(5)
<b>Feature</b> E GIBRALTAR WATERWAY	<b>Length / Width / Spans</b> 26.9 / 37.7 / 1	<b>Owner</b> City: GIBRALTAR(2636)	
<b>Location</b> GIBRALTAR, W/BAYVIEW	<b>Built / Recon. / Paint / Ovly.</b> 1992 / / /	<b>TSC</b> Taylor(25)	<b>Operational Status</b> A Open, no restriction(A)
<b>Region / County</b> Metro(7) / Wayne(82)	<b>Material / Design</b> 5 Prestressed Concrete / 05 Box Bm/Gird- Multiple	<b>Last NBI Inspection</b> 08/02/2023 / GBW2	<b>Scour Evaluation</b> 5 Stable w/in footing

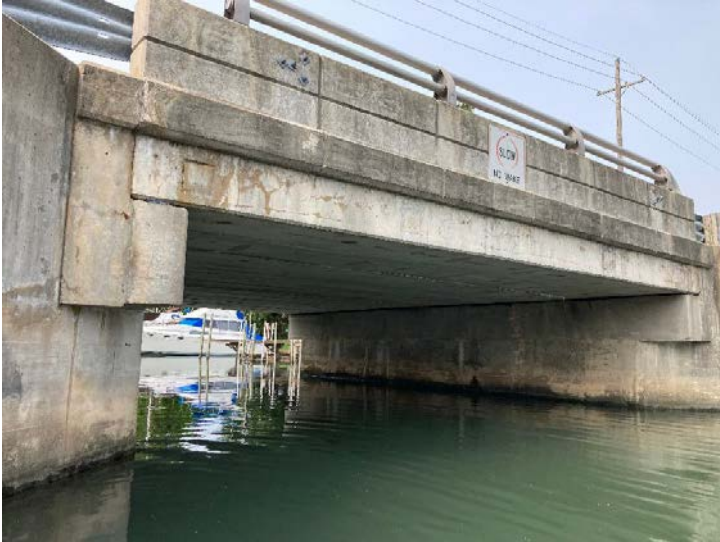
Document Name: IMG\_4564.JPG  
 Category: Elevation  
 Span Number:  
 Comments: North elevation

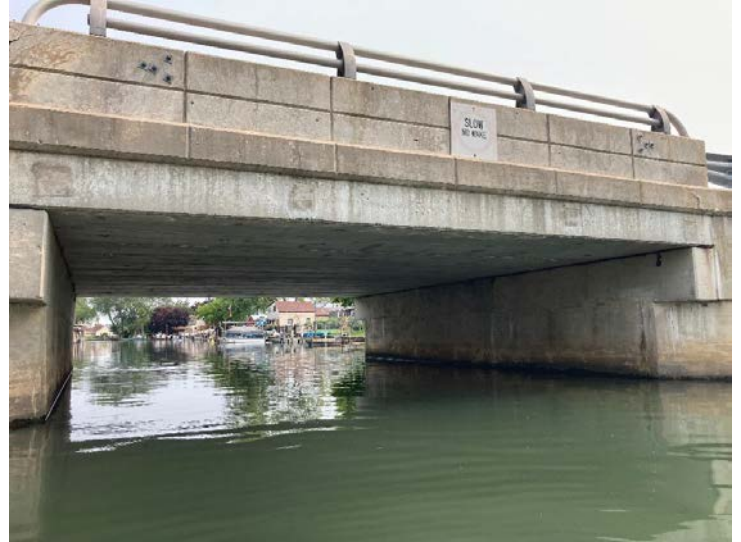
Document Name: IMG\_4569.JPG  
 Category: Elevation  
 Span Number:  
 Comments: South elevation

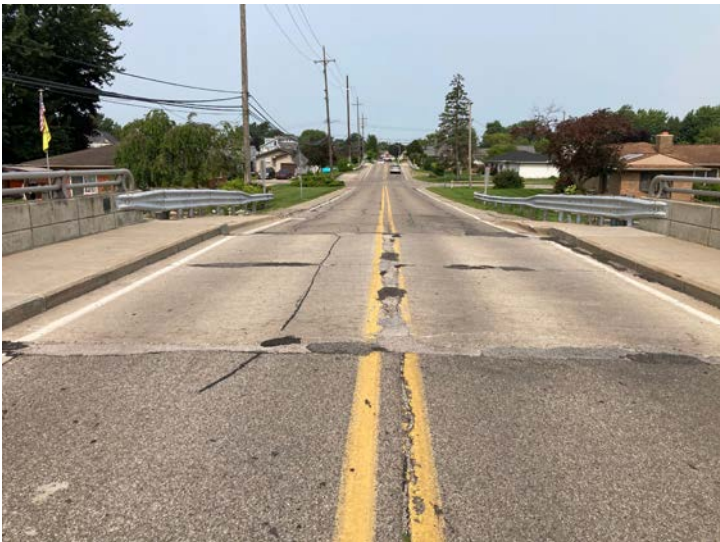
Document Name: IMG\_4552.JPG  
 Category: Approach  
 Span Number:  
 Comments: Looking west through structure

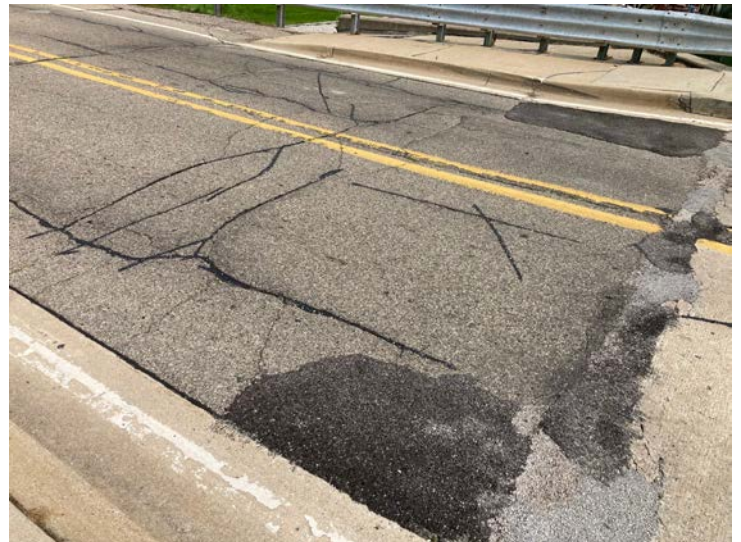
08/19	08/21	08/23	
<b>18. Approach Pavement</b>	6		6	HMA with sealed cracks, sealant beginning to fail. The west approach has HMA wedges at corners. (08/23) HMA with sealed cracks, sealant beginning to fail. The west approach has settled 2"-5". HMA patching at reference lines. (08/21) 95% of the cracks are patched and the patches are beginning to fail. The west approach has settled up to 2 inches. (08/19)
<b>19. Approach Shoulders Sidewalks</b>	6	7	7	Concrete approach sidewalks repaired. 25' of approach sidewalk in each quad. (08/23) Concrete approach sidewalks repaired. 25' of approach sidewalk in each quad. (08/21) Cracks and settlement have been patched with asphalt and sidewalks repaired. (08/19)
<b>20. Approach Slopes</b>				Large, heavy broken pieces of 6 in thick concrete slab. (08/23) Large, heavy broken pieces of 6 in thick concrete slab. No change. (08/21) Large, heavy broken pieces of 6 in thick concrete slab. No change. (08/19)

Document Name: IMG\_4553.JPG  
 Category: Approach  
 Span Number:  
 Comments: West approach

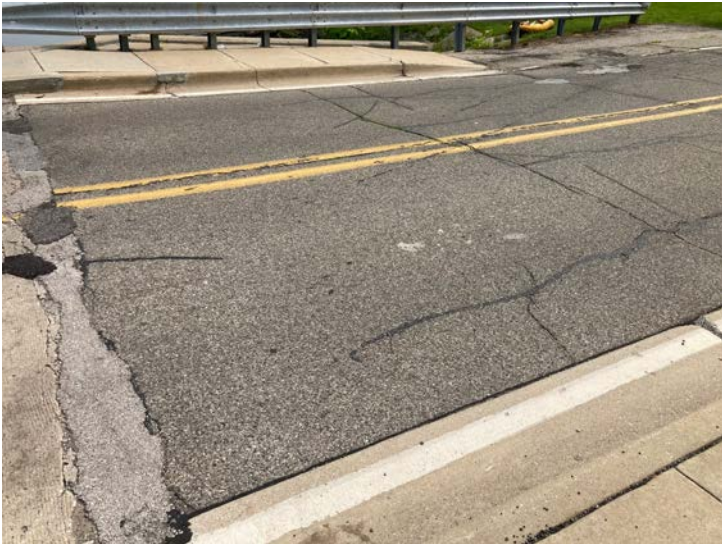
Document Name: IMG\_4557.JPG  
 Category: Approach  
 Span Number:  
 Comments: East approach

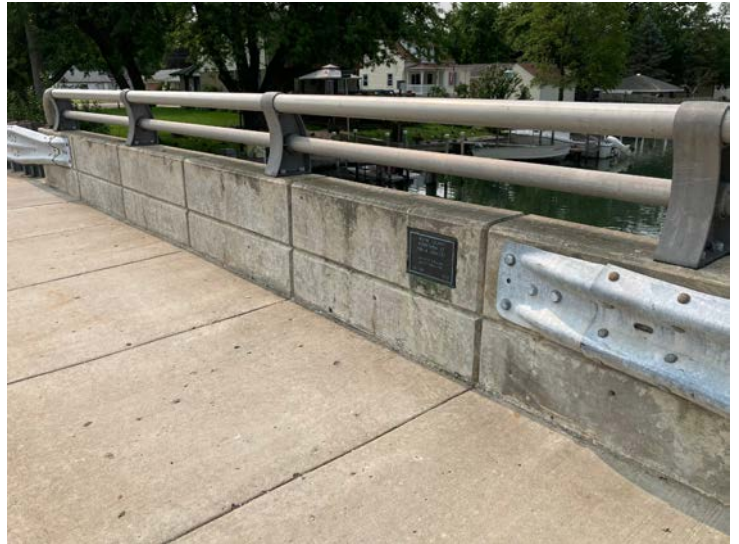
Document Name: IMG\_4559.JPG  
 Category: Railing  
 Span Number:  
 Comments: South rail

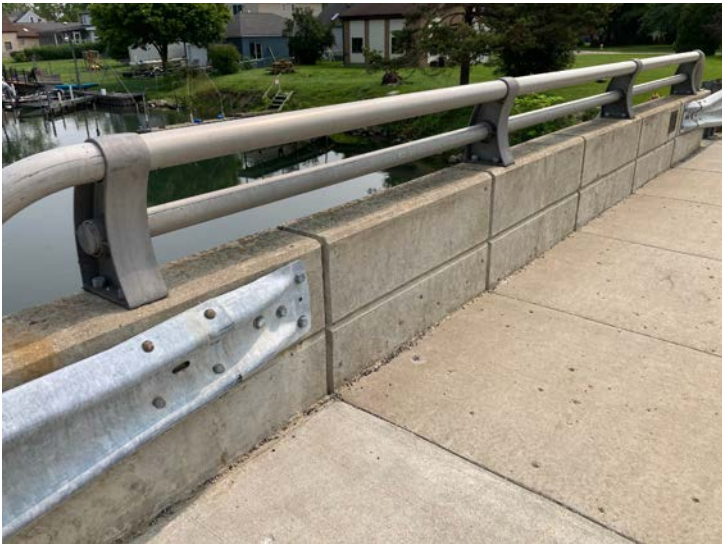
Document Name: IMG\_4562.JPG  
 Category: Railing  
 Span Number:  
 Comments: North rail

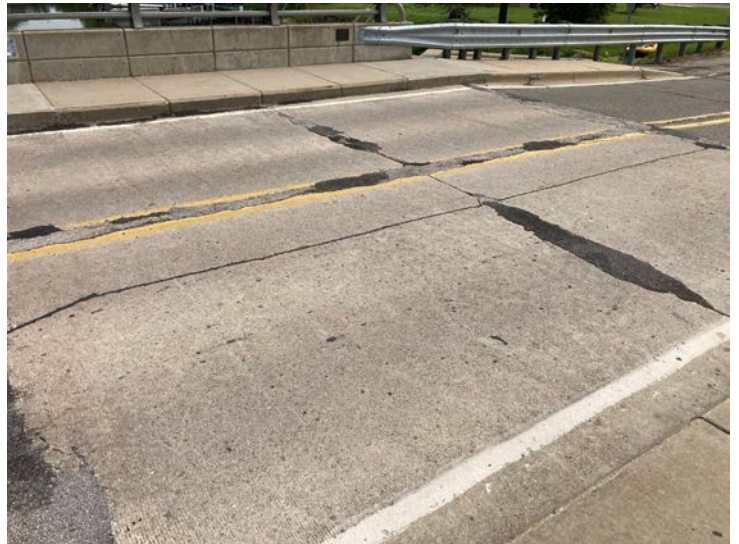
08/19	08/21	08/23	
<b>1. Surface (SIA-58A)</b>	6	5	5	Concrete surface with 3 full length longitudinal cracks. Along centerline, 12" wide HMA patch along full length of bridge. At midspan, 6"-12" wide full width HMA patch. At east end 12" wide full width HMA patch. (08/23) Concrete surface. Along centerline 12" wide HMA patch along full length of bridge. At midspan, 6"-12" wide full width HMA patch. At east end 12" wide full width HMA patch. (08/21) Cracks and spalls at centerline at midspan are patched and sealed, patches are beginning to fail. Spall in east bound lane at east abutment is open. Spalls in west bound lane near the north side walk. (08/19)
<b>2. Expansion Joints</b>	N	N	N	(08/23) (08/21) (08/19)
<b>3. Other Joints</b>	6	4	4	End joints are covered with HMA patch. (08/23) End joints are covered with HMA patch. (08/21) Joints are sealed. (08/19)
<b>4. Railings</b>	6	6	6	Concrete parapet railing. Hairline vertical cracks in both parapets. South railing: West end of parapet has 1sft map cracking and spalling (8 in x 6 in x 2 in pen). Cracked weld at the SE metal rail to base plate connection. North railing: Metal railing base plate at NE end has 1 of 4 nuts missing. The nuts were generally poorly tightened on the metal railings. (08/23) Concrete parapet railing. Hairline vertical cracks in both parapets. West end of south parapet has 1sft map cracking and spalling (8 in x 6 in x 2 in pen). Metal railing base plate at NE end has 1 of 4 nuts missing. The nuts were generally poorly tightened on the metal railings. Cracked weld at the SE metal rail to base plate connection. (08/21) Hairline vertical cracks in both parapets. West end of south parapet has 1 sq. ft. area of heavy 1/16 in. map cracking and spalling (8 in x 6 in x 2 in pen). Metal railing base plate at NE end has 1 of 4 nuts missing. The nuts were generally poorly tightened on the metal railings. Cracked weld at the SE metal rail to base plate connection. (08/19)

Document Name: IMG\_4555.JPG  
 Category: Deck  
 Span Number:  
 Comments: Deck surface

Apply for PM work.

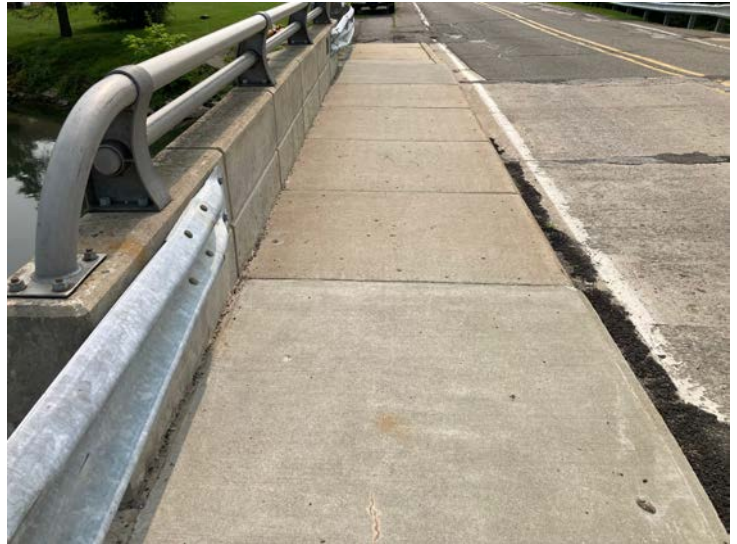
Document Name: IMG\_4561.JPG  
 Category: Deck  
 Span Number:  
 Comments: North sidewalk

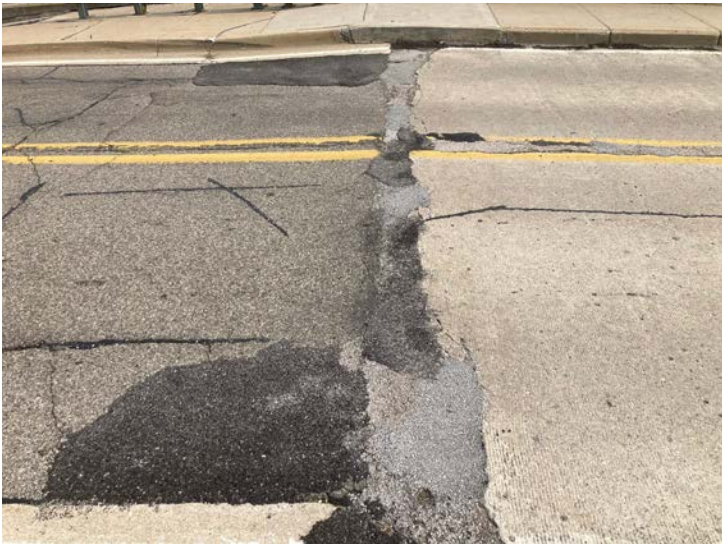
Document Name: IMG\_4554.JPG  
 Category: Joints  
 Span Number:  
 Comments: West reference line

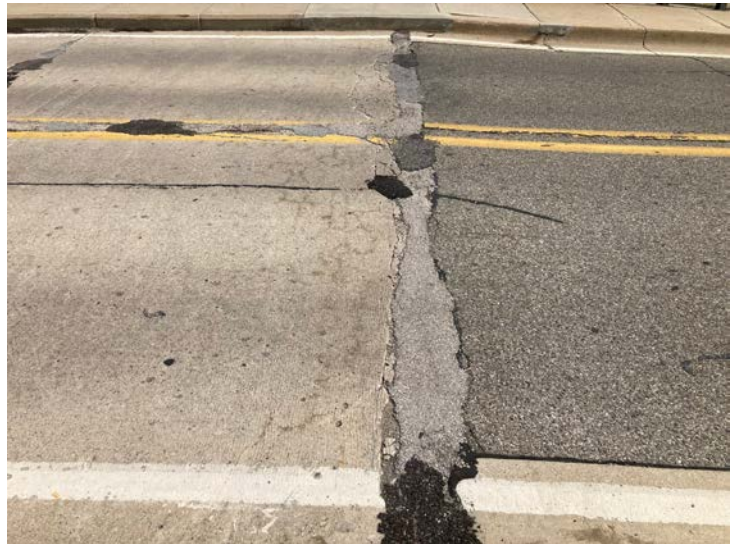
Document Name: IMG\_4556.JPG  
 Category: Joints  
 Span Number:  
 Comments: East reference line

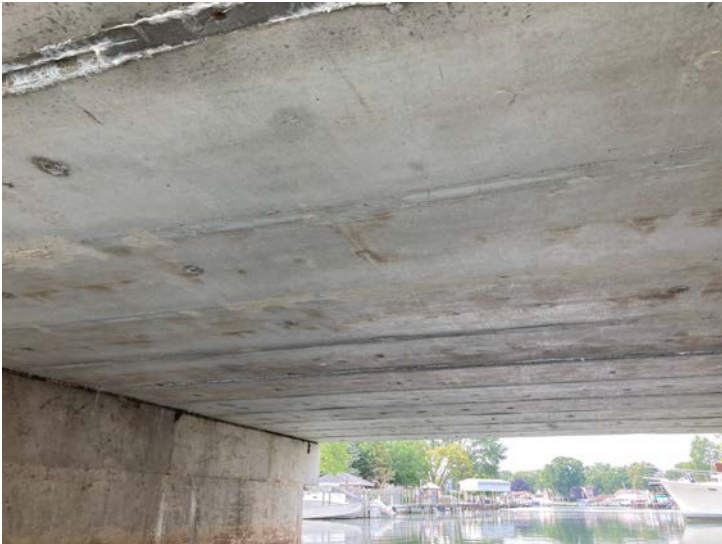
Document Name: IMG\_4567.JPG  
 Category: Superstructure  
 Span Number:  
 Comments: Beams

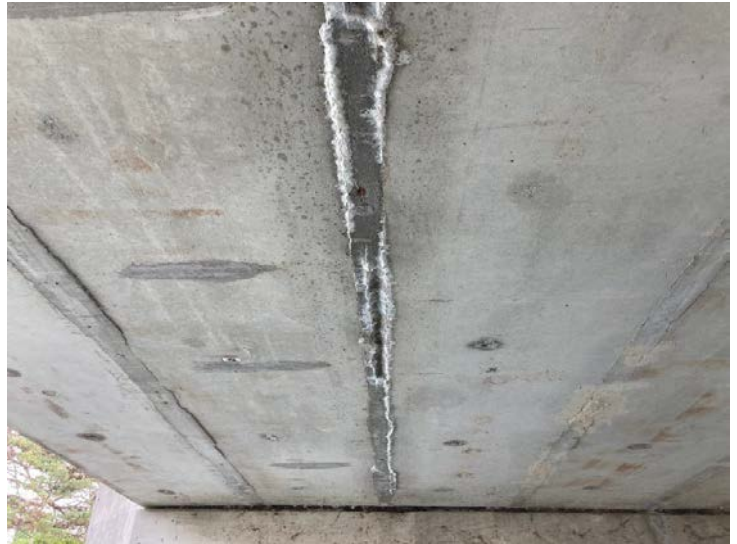
Document Name: IMG\_4568.JPG  
 Category: Superstructure  
 Span Number:  
 Comments: Leakage between beams

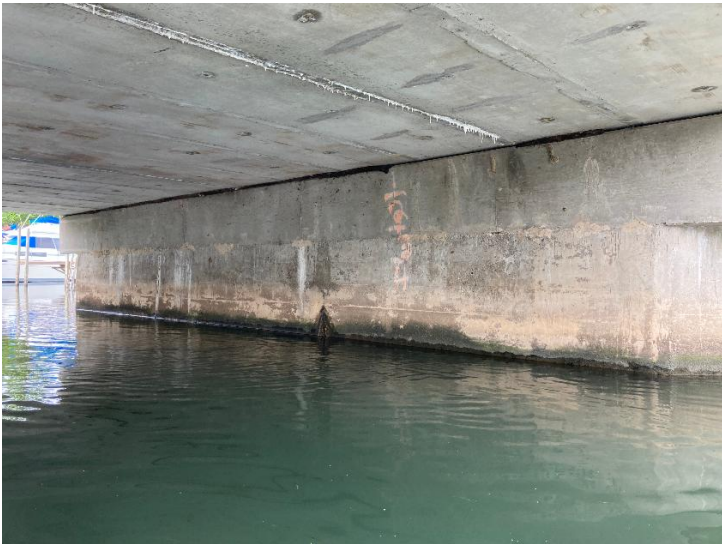
Document Name: IMG\_4565.JPG  
 Category: Substructure  
 Span Number:  
 Comments: West abutment

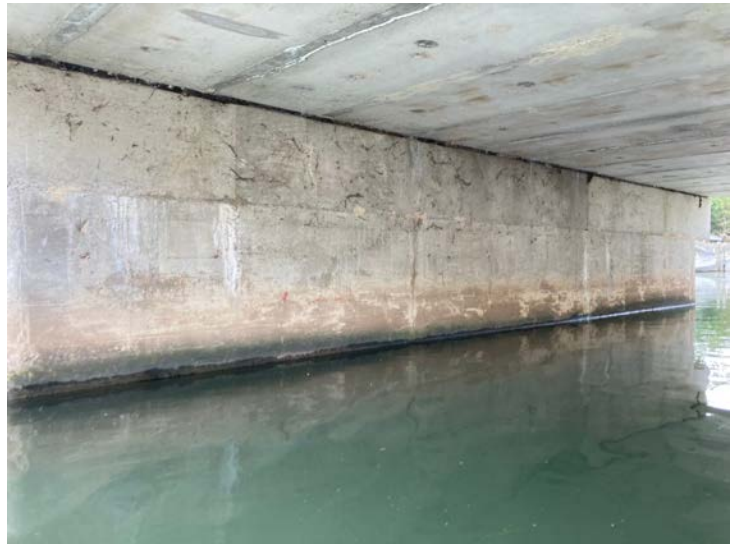
Document Name: IMG\_4566.JPG  
 Category: Substructure  
 Span Number:  
 Comments: East abutment

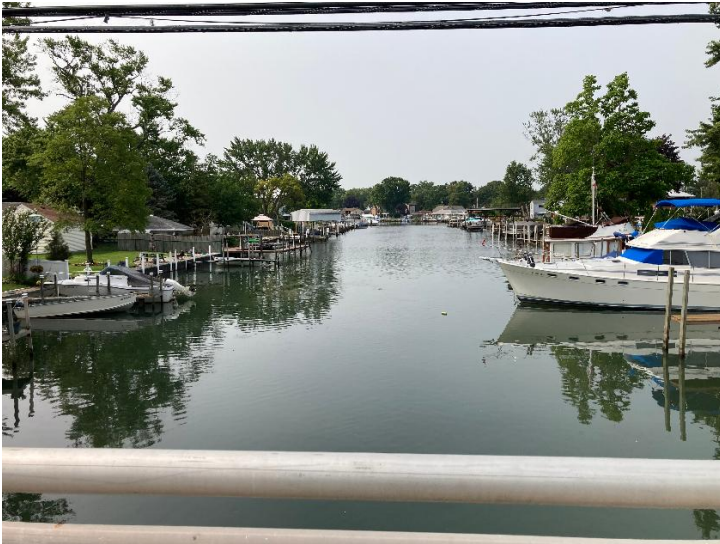
<b>14. Piers (SIA-60)</b>	N	N	N	(08/23) (08/21) (08/19)
<b>15. Slope Protection</b>	N	N	N	(08/23) (08/21) Not used as structure crosses waterway. (08/19)
<b>16. Channel (SIA-61)</b>	8	8	8	Flow north to south. Waterway is open. Retaining walls at NW, SE, and SW quadrants, and embankment with riprap at the NE quadrant. (08/23) Waterway is open. Retaining walls at NW, SE, and SW quadrants, and embankment with riprap at the NE quadrant. (08/21) Waterway is open. Private property retaining walls at NW, SE, and SW quadrants, and embankment with 1 ft. diameter rip rap at the NE quadrant. (08/19)
<b>17. Scour Inspection</b>	8	8	8	2021 UW inspection found no footing exposure or undermining along the abutments. (08/23) See 2021 UW inspection (08/21) Probed from boat. No scour observed. (08/19)

Document Name: IMG\_4560.JPG  
 Category: Channel  
 Span Number:  
 Comments: South channel

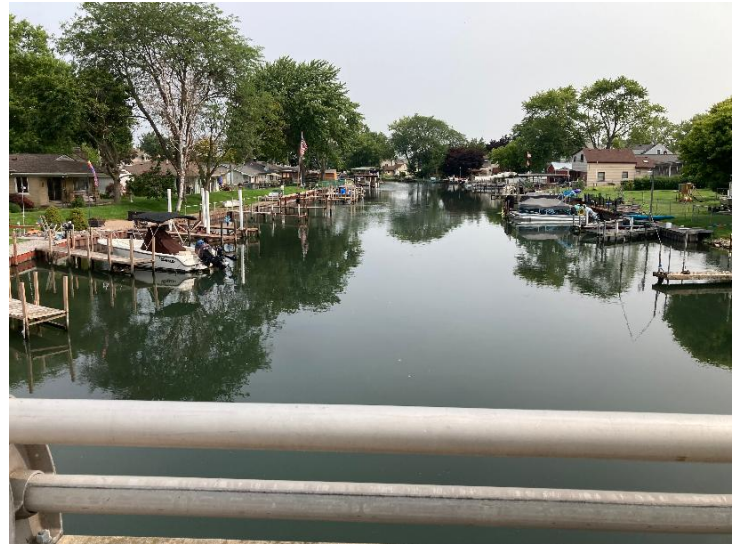
Document Name: IMG\_4563.JPG  
 Category: Channel  
 Span Number:  
 Comments: North channel
