MICHIGAN DEPARTMENT OF TRANSPORTATION

STR 11997

BRIDGE SAFETY INSPECTION REPORT

Facility	Latitude / Longitude	MDOT Structure ID	Structure Condition	 
GIBRALTAR ROAD	42.0947 / -83.2028	824263600007B01	Poor Condition(4)	
Feature	Length / Width / Spans	Owner		
FRANK & POET DRAIN	27.2 / 55.8 / 1	City: GIBRALTAR(2636)		
Location	Built / Recon. / Paint / Ovly.	TSC	Operational Status	
GIBRALTAR E/JEFFERSON	1932 / / /	Taylor(25)	A Open, no restriction(A)	
Region / County	Material / Design	Last NBI Inspection	Scour Evaluation	
Metro(7) / Wayne(82)	1 Concrete / 04 Tee Beam	08/02/2023 / 6MB5	3 SC - Unstable

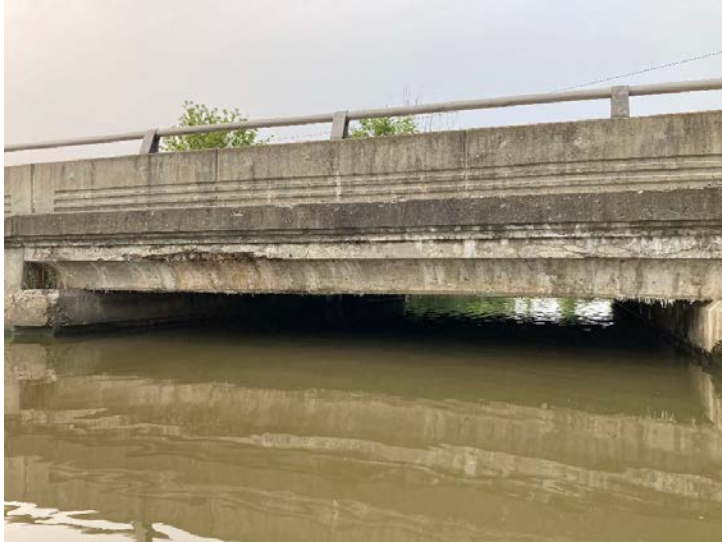
Document Name: IMG_4503.JPG
 Category: Elevation
 Span Number:
 Comments: North elevation

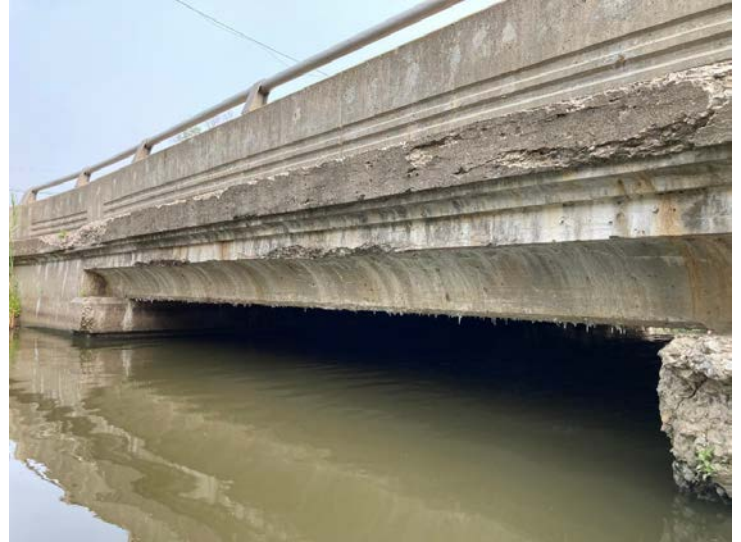
Document Name: IMG_4509.JPG
 Category: Elevation
 Span Number:
 Comments: South elevation

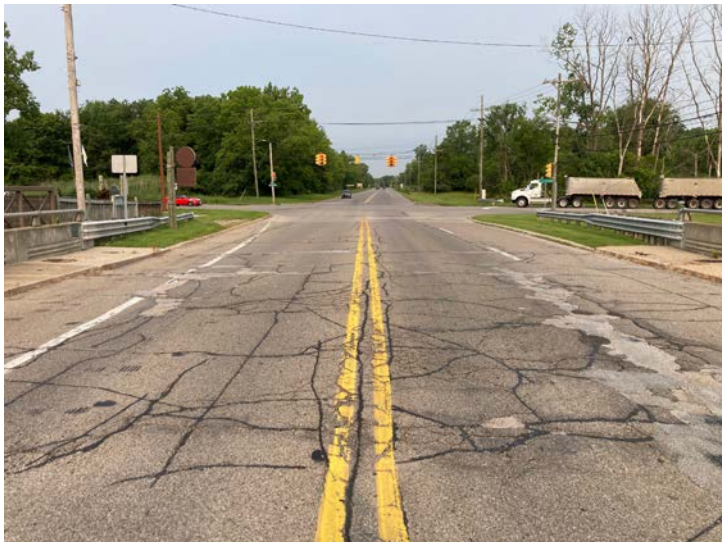
Document Name: IMG_4492.JPG
 Category: Approach
 Span Number:
 Comments: Looking west through structure

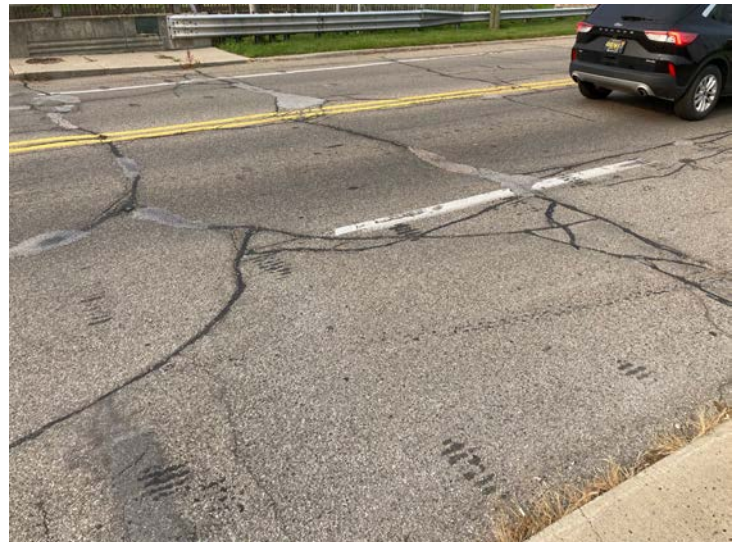
08/21	08/22	08/23	
18. Approach Pavement	4	4	4	HMA approaches. Heavy cracking, some sealed with rutting and bit filled spalls. Estimate 2"-4" settlement at reference lines is causing impact loading. (08/23) Bit approaches. Heavy cracking, some sealed with rutting and potholes. Estimate 2"-4" settlement at reference lines is causing impact loading. (08/22) Bit approaches. Heavy cracking, rutting and potholes. Estimate 2"-4" settlement at reference lines is causing impact loading. (08/21)

Document Name: IMG_4493.JPG
 Category: Approach
 Span Number:
 Comments: West approach

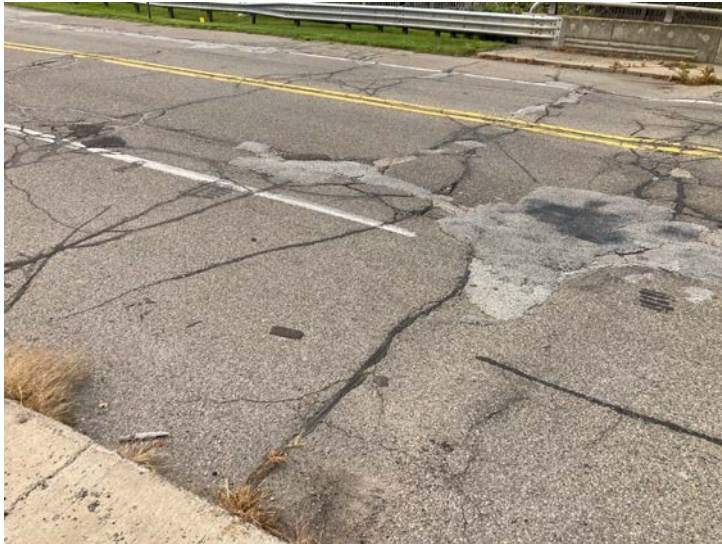
Document Name: IMG_4495.JPG
 Category: Approach
 Span Number:
 Comments: East approach

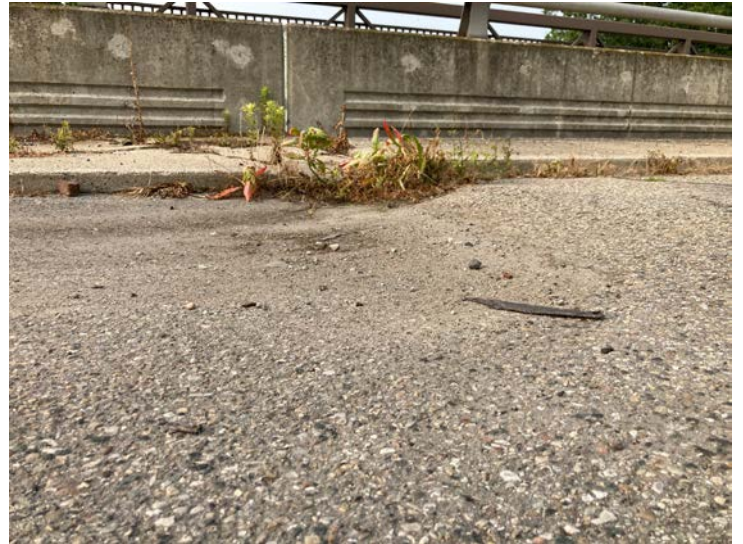
19. Approach Shoulders Sidewalks	4	4	4	Approx 2"-4" of settlement in all quadrants. Bit shoulders are settled and heavily cracked, worse along south shoulder. East: large dip at reference line along both lanes. West: bit patches at reference line. (08/23) Approx 2"-4" of settlement in all quadrants. Bit shoulders are settled and heavily cracked. East: large dip at reference line along both lanes. West: bit patches at reference line. (08/22) Approx 2"-4" of settlement in all but southwest quadrant at sidewalks. Bit shoulders are settled and heavily cracked. (08/21)

Document Name: IMG_4499.JPG
 Category: Approach
 Span Number:
 Comments: Settlement at approaches

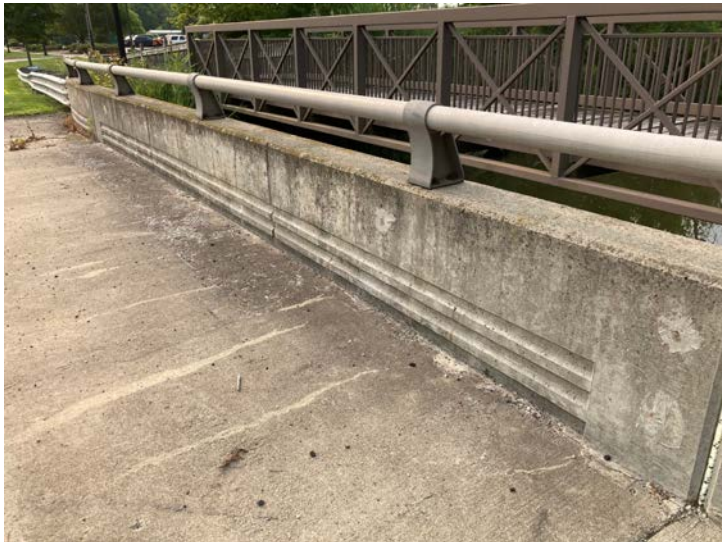
2. Expansion Joints	N	N	N	(08/23) (08/22) (08/21)
3. Other Joints	N	N	N	(08/23) (08/22) (08/21)
4. Railings	6	6	6	Concrete parapet with aluminum ped tube. Hairline vertical cracks with some rusting/leaching every 12". Several small spalls. (08/23) Concrete parapet with aluminum ped tube. Hairline vertical cracks with some rusting every 12". Several small spalls. (08/22) Concrete parapet with aluminum ped tube. Hairline vertical cracks every 12".. Several small spalls. (08/21)

Document Name: IMG_4497.JPG
 Category: Railing
 Span Number:
 Comments: South rail

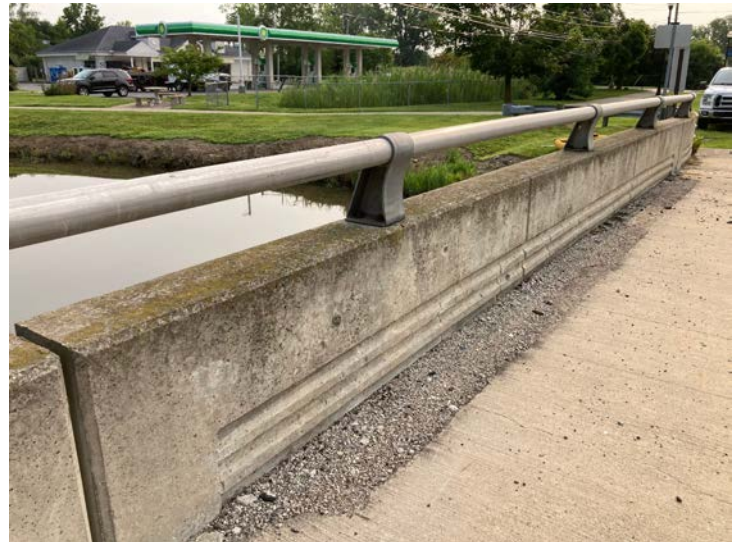
Document Name: IMG_4501.JPG
 Category: Railing
 Span Number:
 Comments: North rail

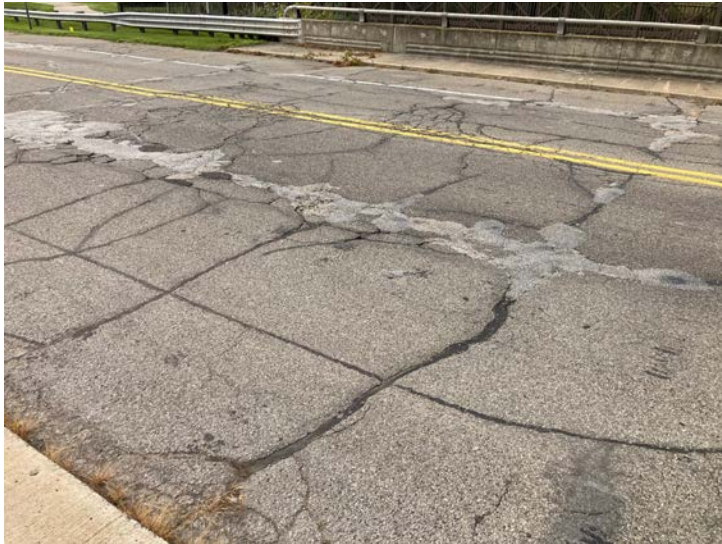
08/21	08/22	08/23	
1. Surface (SIA-58A)	4	4	4	HMA surface. Rutting, open and sealed cracks, HMA patches, and alligator cracks. Several bit filled spalls in south lane. Vegetation growth at sidewalk. Impact loading due to surface deterioration and settled approaches. Estimate 40% of surface patched/cracked. WB has extensive bit spalls in the right wheel path. Alligator cracks along centerline and east half. (08/23) Bit surface. Rutting, open and sealed cracks, HMA patches, and alligator cracks. Several open spalls in south lane. Vegetation growth at sidewalk. Impact loading due to surface deterioration and settled approaches. Estimate 40% of surface patched/cracked. WB has extensive bit spalls in the right wheel path. Alligator cracks along centerline. (08/22) Bit surface. Rutting, open and sealed cracks, HMA patches, and alligator cracks. Several open spalls in south lane. Vegetation growth at sidewalk. Impact loading due to surface deterioration. Estimate 40% of surface patched/cracked. (08/21)

Document Name: IMG_4494.JPG
 Category: Deck
 Span Number:
 Comments: HMA surface

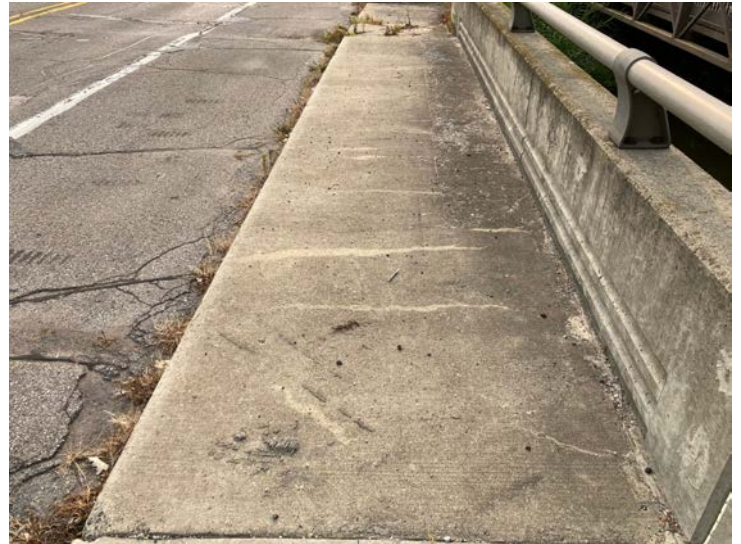
5. Sidewalks or Curbs	6	6	6	5.5' wide raised concrete sidewalks. 2 spalls in north sidewalk adjacent to traffic. Transverse cracks at approximately 4' spacing. Shallow scale in north and south sidewalk near rail. Gravel on outside 2' of both sidewalks. (08/23) 5.5' wide raised concrete sidewalks. Spalls at north edge adjacent to traffic. Transverse cracks at approximately 4' spacing. Shallow scale in south sidewalk near rail. Gravel on outside 2' of both sidewalks. (08/22) Raised concrete sidewalks. Spalls at edge adjacent to traffic. Transverse cracks at approximately 4' spacing. Shallow scale in south sidewalk. Gravel on outside 2' of both sidewalks. (08/21)

Document Name: IMG_4496.JPG
 Category: Deck
 Span Number:
 Comments: South sidewalk

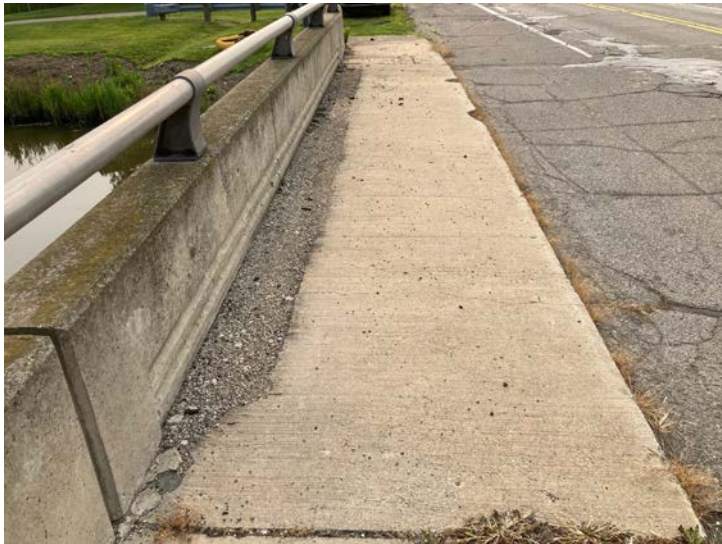
Document Name: IMG_4500.JPG
 Category: Deck
 Span Number:
 Comments: North sidewalk

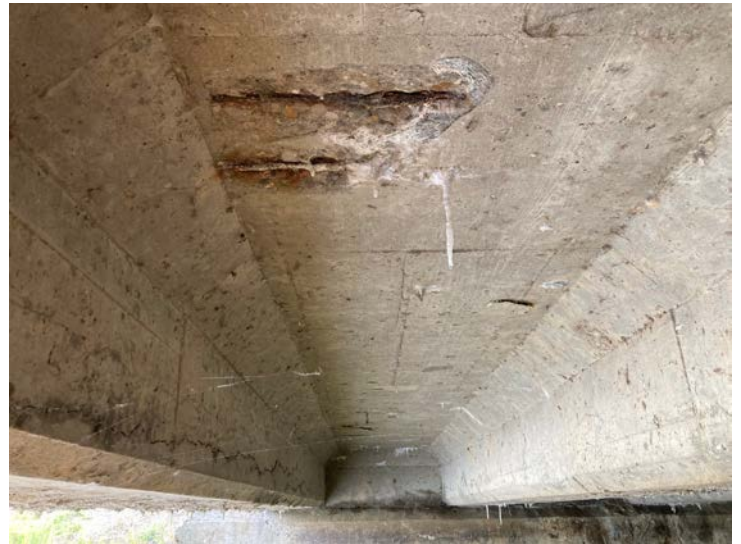
6. Deck Bottom Surface (SIA-58B)	4	4	4	Concrete deck. Scale and spalls on both fascias and all bays. Transverse and leaching map cracks throughout. Areas of honey combing. (08/23) Concrete deck. Scale and spalls on both fascias and all bays. Transverse and leaching map cracks throughout. Areas of honey combing. (08/22) Previous comments: Concrete deck. Scale and spalls on both fascias and all bays. Transverse leaching cracks throughout. 18" of freeboard, could not go under bridge in 2022. (08/21)

Document Name: IMG_4507.JPG
 Category: Deck
 Span Number:
 Comments: Deck bottom

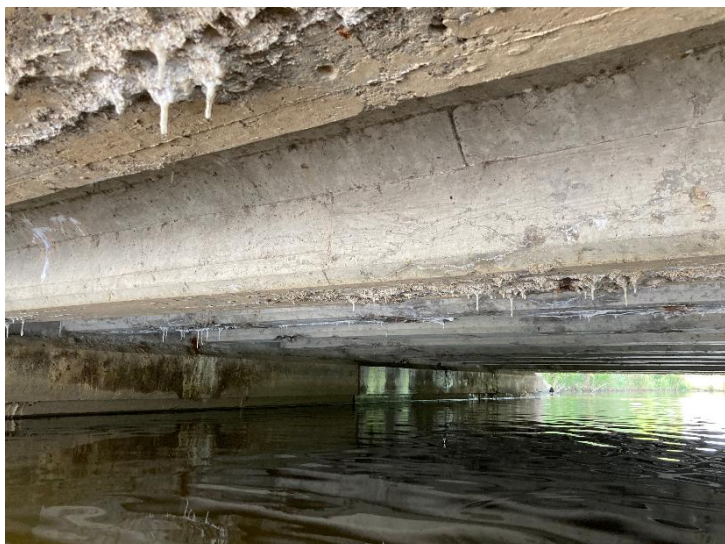
9. Stringer (SIA-59) 4 4 4 CIP T Beams. All T beams have longitudinal cracks. Many have open spalls with exposed rebar. Many areas of honeycomb. Most spalls are at 1/4 points. None of the exposed reinforcement completely debonded from the concrete. Deterioration as follows:
 BM1s - 4' spall with no exposed steel.
 BM4s - 6' STS with 5 Ea exposed longitudinal bars.
 BM5s - 2' shallow spall and delam.
 BM6s - 3' STS with 5 Ea exposed longitudinal bars at east 1/4.
 BM7s - 6' STS with 5 Ea exposed longitudinal bars at east 1/4.
 BM8s - 4' STS with 5 Ea exposed longitudinal bars.
 BM9s - 1' STS with 5 Ea exposed longitudinal bars.
 BM10s - 2' STS with 3 Ea exposed longitudinal bars at midspan. (08/23)
 CIP T Beams. All T beams have longitudinal cracks. Many have open spalls with exposed rebar. Many areas of honeycomb. Most spalls are at 1/4 points. None of the exposed reinforcement completely debonded from the concrete. Deterioration as follows:

Comments: Beams

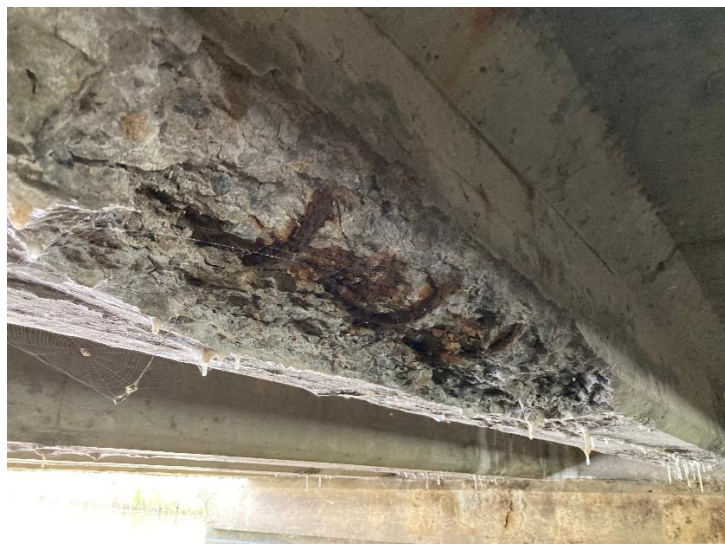
BM1s - 4' spall with no exposed steel.
 BM4s - 6' STS with 5 Ea exposed longitudinal bars.
 BM5s - 2' shallow spall and delam.
 BM6s - 3' STS with 5 Ea exposed longitudinal bars at east 1/4.
 BM7s - 6' STS with 5 Ea exposed longitudinal bars at east 1/4.
 BM8s - 4' STS with 5 Ea exposed longitudinal bars.
 BM9s - 1' STS with 5 Ea exposed longitudinal bars.
 BM10s - 2' STS with 3 Ea exposed longitudinal bars at midspan. (08/22)
 Previous comments: CIP T Beams. All T beams have longitudinal cracks. Many have open spalls with exposed rebar. Many areas of honeycomb. Most spalls are at 1/4 points. T beams at construction joints are worse than others.
 18" of freeboard, could not go under bridge in 2022. (08/21)

11. Section Loss 2 1 1 Cracks and spalls at beam ends. Exposed reinforcement has rust and scale. (08/23)
 Cracks and spalls at beam ends. Exposed reinforcement has rust and scale. (08/22)
 Cracks and spalls at beam ends. No shear cracks. (08/21)

Comments: Spall to steel in beams, typical

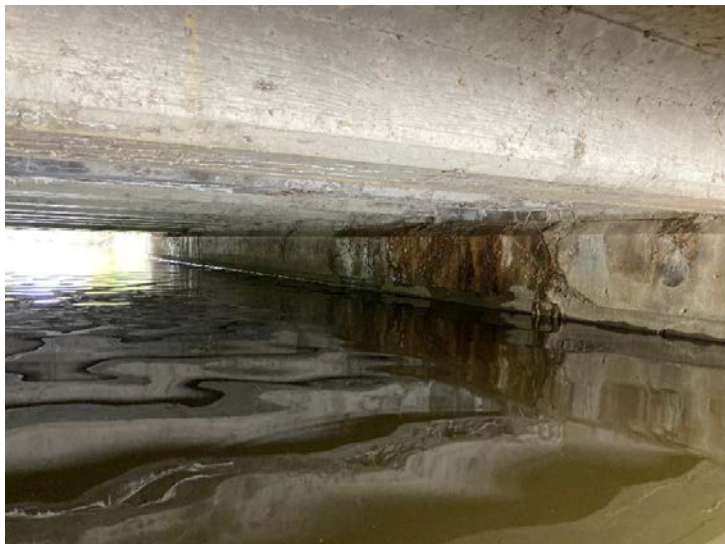
13. Abutments (SIA-60)	4	4	4	Concrete abutments mostly submerged at time of inspection. Open cracks in caps and walls were worse near normal water line, but no offsets noted. Corners are scalled/spalled where exposed with rusty rebar exposed. Leakage and wetness along length of both abutments. 2021 Underwater inspection noted: Advanced scour with vertical footing exposure was noted along the west and east abutments during the underwater inspection. Footing exposure along the west abutment starts under beam 3s and runs out under beam 10s. Footing exposure ranges from 0" to 2" maximum. At the east abutment, footing exposure starts under beams 1n -2n and zeroes out under beams 6n-7n. Footing exposure at the east abutment ranged from 0" to 1'-6" maximum. No undermining was noted along the abutments. (08/23) Concrete abutments mostly submerged at time of inspection. Open cracks in caps and walls were worse near normal water line, but no offsets noted. Corners are scalled/spalled where exposed with rusty rebar exposed. Leakage and wetness along length of both abutments. 2021 Underwater inspection noted: Advanced scour with vertical footing exposure was noted along the west and east abutments during the underwater inspection. Footing exposure along the west abutment starts under beam 3s and runs out under beam 10s. Footing exposure ranges from 0" to 2" maximum. At the east abutment, footing exposure starts under beams 1n -2n and zeroes out under beams 6n-7n. Footing exposure at the east abutment ranged from 0" to 1'-6" maximum. No undermining was noted along the abutments. (08/22) Previous comments: Concrete abutments mostly submerged at time of inspection. Open cracks in caps and walls were worse near normal water line, but no offsets noted. Corners are scalled/spalled where exposed with rusty rebar exposed. Leakage and wetness along length of both abutments. 18" of freeboard, could not go under bridge in 2022. (08/21)

Comments: West abutment

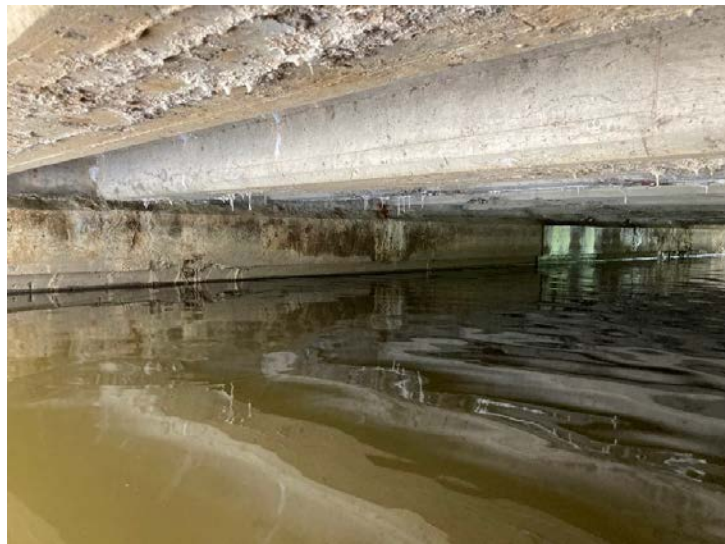
Comments: East abutment

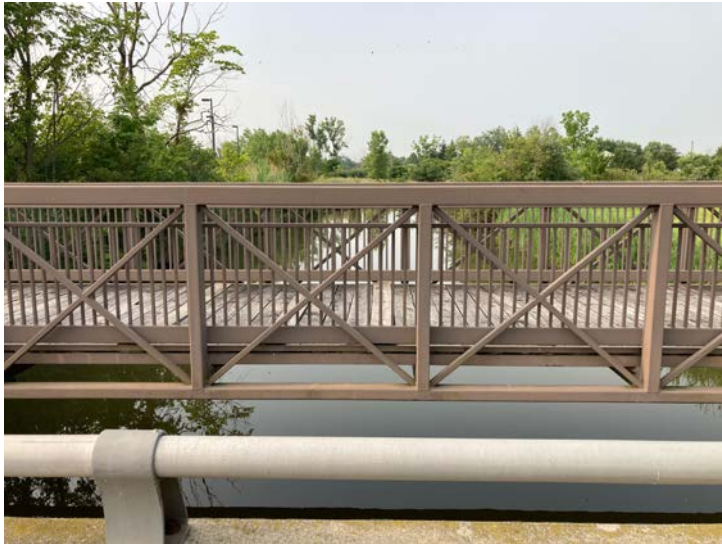
14. Piers (SIA-60)	N	N	N	(08/23) (08/22) (08/21)
15. Slope Protection	N	N	N	(08/23) (08/22) (08/21)
16. Channel (SIA-61)	7	7	7	Slow flow south to north. Waterway is open. Heavy vegetation on banks. Bridge too small for channel. (08/23) Waterway is open. Heavy vegetation on banks. Bridge too small for channel. (08/22) Waterway is open. Heavy vegetation on banks. Bridge too small for channel. (08/21)

Document Name: IMG_4498.JPG
 Category: Channel
 Span Number:
 Comments: South channel

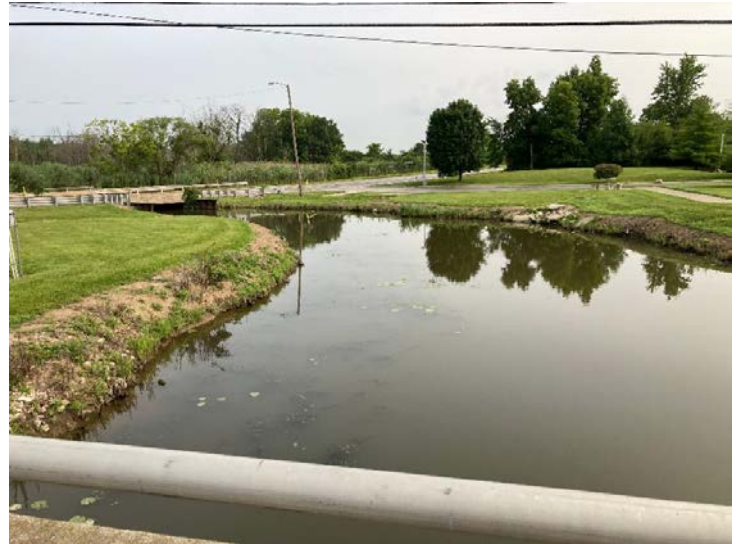
Document Name: IMG_4502.JPG
 Category: Channel
 Span Number:
 Comments: North channel
