MICHIGAN DEPARTMENT OF TRANSPORTATION

STR 11998

BRIDGE SAFETY INSPECTION REPORT

NBI INSPECTION

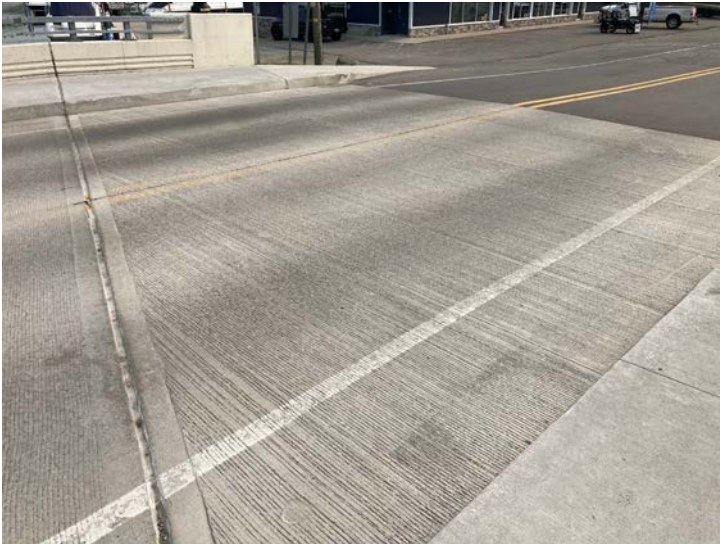
18. Approach Pavement	7	9	8	Concrete approaches adjacent to bridge with HMA approaches ~20' beyond. Diagonal crack in east approach near sidewalk (08/23) Concrete approaches adjacent to bridge with HMA approaches ~20' beyond. (02/22) HMA approaches. Transverse and random cracks are mostly sealed. (08/20)
------------------------------	---	---	---	---

Document Name: IMG_4516.JPG
 Category: Approach
 Span Number:
 Comments: East approach

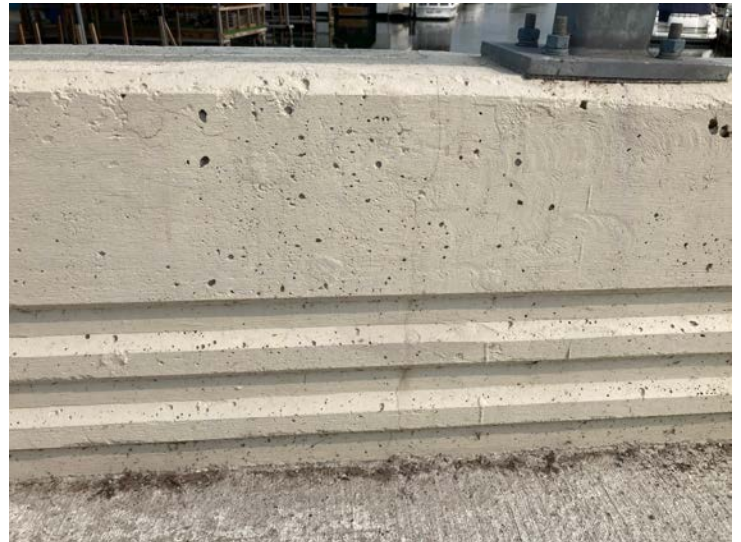
3. Other Joints	N	N	N	(08/23) N/A (02/22) Paved over. (08/20)
4. Railings	5	9	8	Concrete aesthetic parapet tube with concrete surface coating and stone pattern on fascias. 1 HL vertical crack in north rail at midspan. Numerous popouts on both railings. (08/23) Aesthetic Parapet Tube on each sidewalk with stone pattern on fascias. Numerous popouts on both railings. (02/22) Decorative granite railing. Scale on top surface. Few areas of deep scale. Several cracks up to 1/8" wide. Brushblocks and columns patched. (08/20)

Document Name: IMG_4524.JPG
 Category: Railing
 Span Number:
 Comments: HL vertical crack in north rail

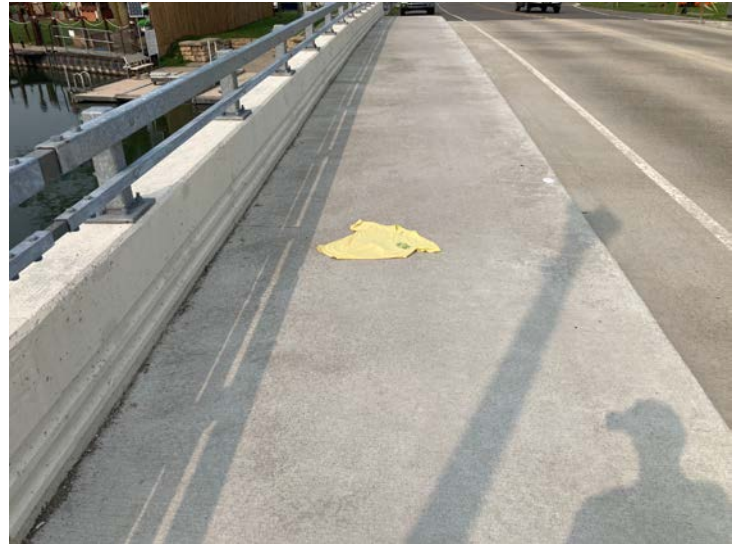
5. Sidewalks or Curbs	6	9	8	Sidewalks on each side, no deficiencies noted. (08/23) Sidewalks on each side, snow covered at time of inspection. (02/22) Raised concrete sidewalks on both sides. Transverse cracks at 4' spacing. There are a few rust stains. (08/20)

Document Name: IMG_4517.JPG
 Category: Deck
 Span Number:
 Comments: South sidewalk

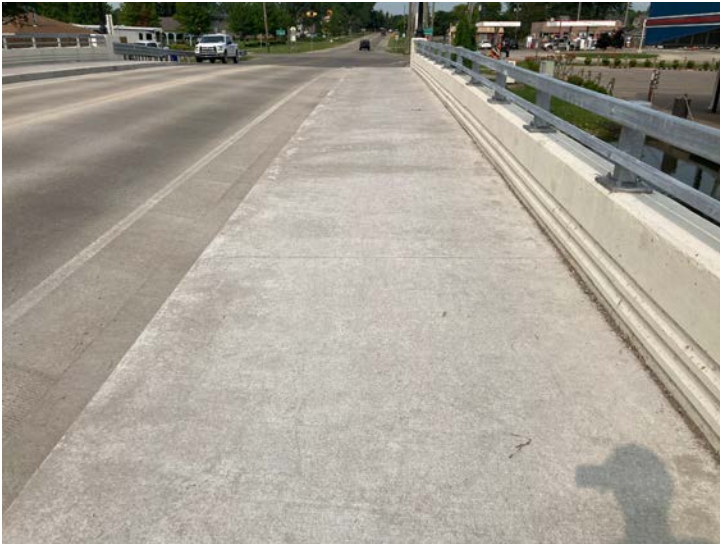
Document Name: IMG_4520.JPG
 Category: Deck
 Span Number:
 Comments: North sidewalk

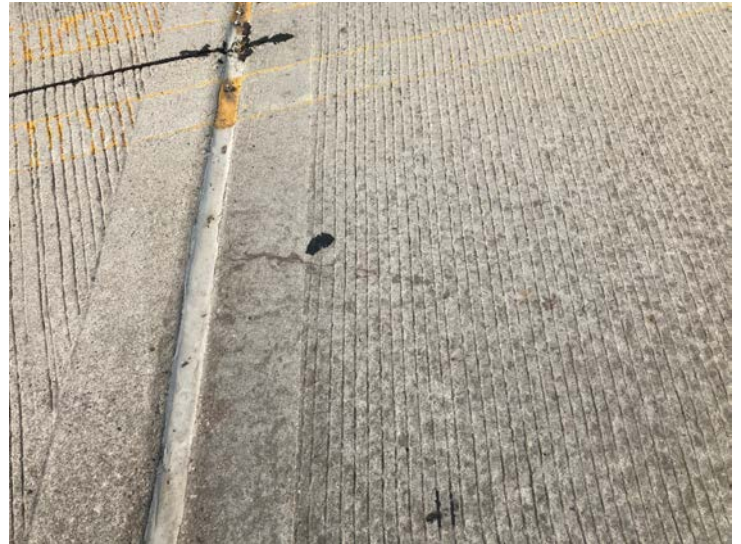
08/20	02/22	08/23	
1. Surface (SIA-58A)	6	9	8	Concrete deck with tined surface. 4 short longitudinal cracks propagating from east reference line, 1 at west reference line. Very small spall near reference line of west joint in WB lane, most likely from plow. (08/23) New concrete deck with tined surface. Very small spall near reference line of west joint in WB lane, most likely from plow. (02/22) HMA over deck. Many sealed and unsealed random cracks. Few patched areas in shoulders. (08/20)

Document Name: IMG_4523.JPG
 Category: Deck
 Span Number:
 Comments: Longitudinal cracks in deck surface

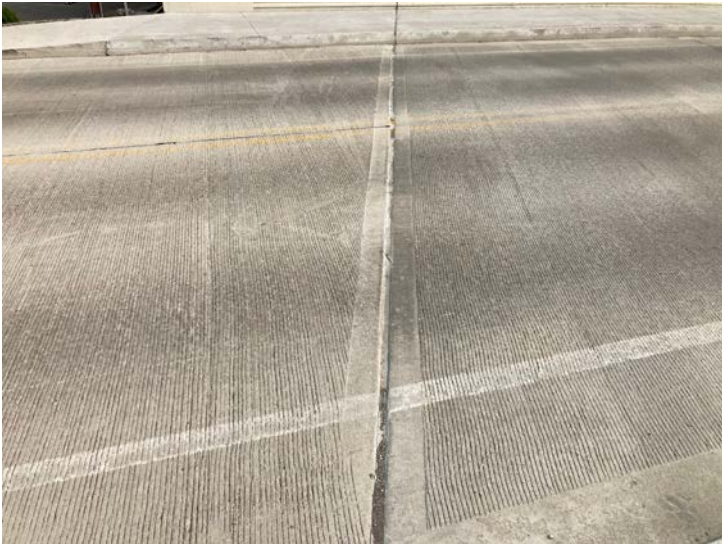
2. Expansion Joints	N	9	8	E3 joints at reference lines, approx 1/4" below surface. Minor LOA throughout. (08/23) E3 joints at reference lines, approx 1/4" below surface. (02/22) Paved over. (08/20)

Document Name: IMG_4513.JPG
 Category: Joints
 Span Number:
 Comments: West reference line

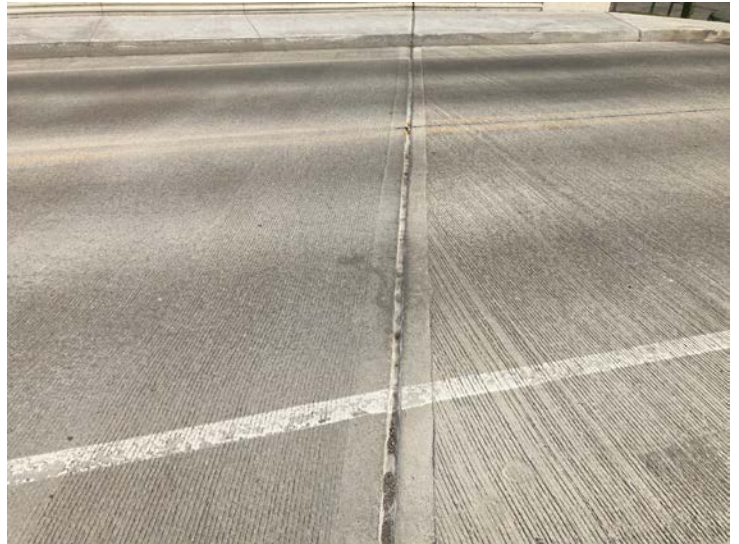
Document Name: IMG_4515.JPG
 Category: Joints
 Span Number:
 Comments: East reference line

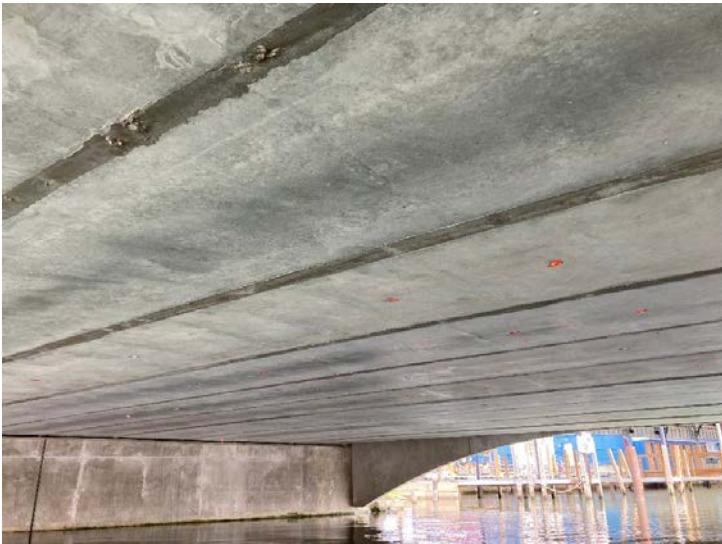
9. Stringer (SIA-59)	1	9	8	11 (EA) adjacent box beams with panels attached to fascia beams. No deficiencies noted in either. (08/23) Adjacent box beams with panels attached to fascia beams. No deficiencies noted in either. (02/22) Concrete on the cantilever variable depth T beams with dapped ends and suspended span. Cracking, delamination and spalls in all beams with bottom and second row of rebar exposed in several. Suspended span is delaminated throughout with open spalls and rebar no longer connected. Spalls at joint location with primary rebar holding dapped end exhibiting heavy section loss (over 50%) and crumbling concrete at hooks no longer providing development length. RFA sent to close the bridge while on site on 9/1/2020. Bridge closed on 9/2/2020. (08/20)

Document Name: IMG_4528.JPG
 Category: Superstructure
 Span Number:
 Comments: Beams

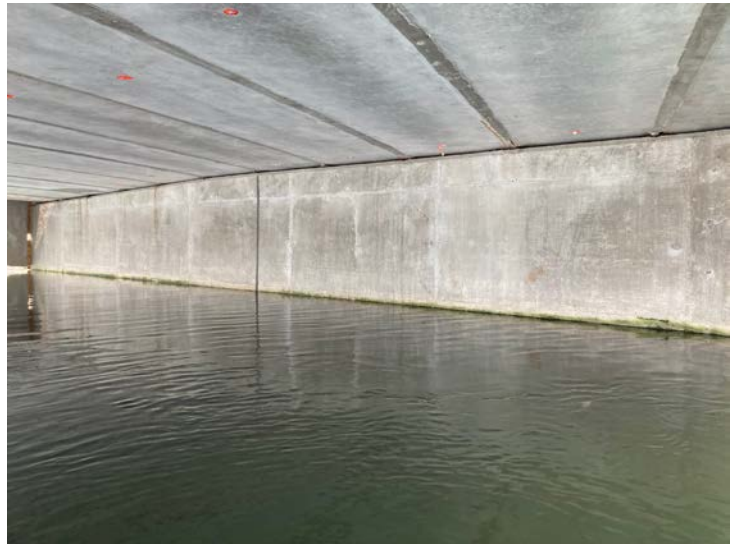
13. Abutments (SIA-60)	6	9	8	Concrete cantilever abutments with no deficiencies noted. (08/23) Cantilever abutments with no deficiencies noted. (02/22) Abutments are not visible for inspection. Assumed to be in similar condition to the piers. (08/20)

Document Name: IMG_4526.JPG
 Category: Substructure
 Span Number:
 Comments: West abutment

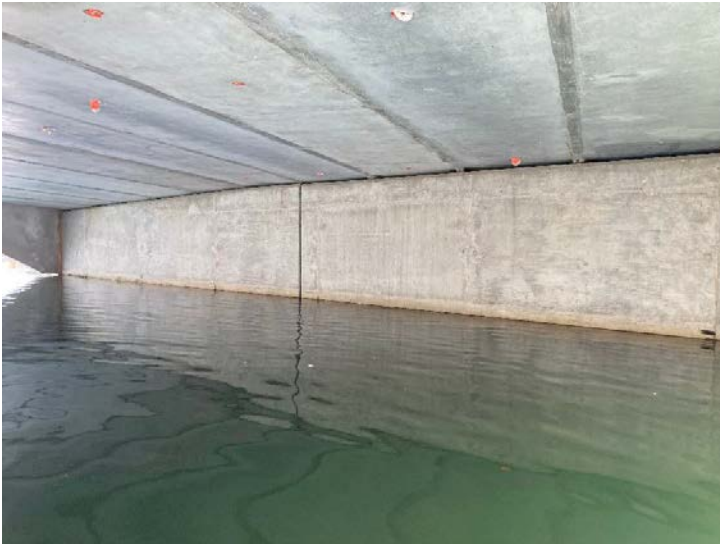
Document Name: IMG_4527.JPG
 Category: Substructure
 Span Number:
 Comments: East abutment

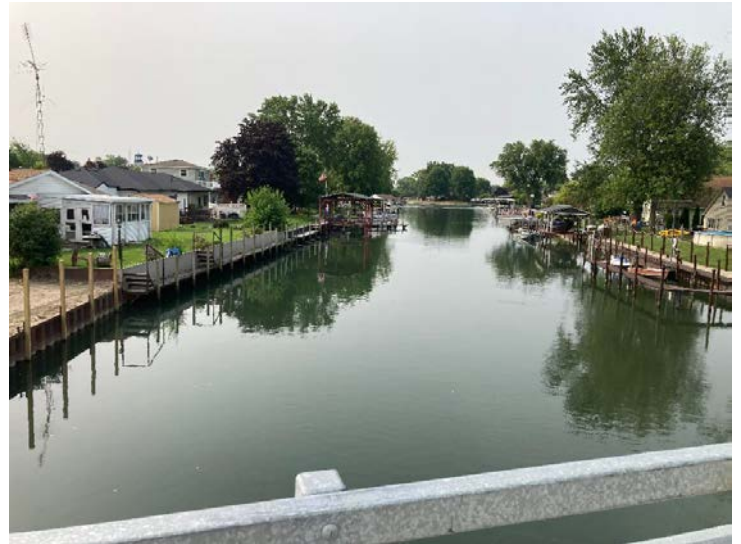
15. Slope Protection	N	9	N	(08/23) Riprap placed in front of new abutments. (02/22) (08/20)
16. Channel (SIA-61)	7	9	8	Flow north to south. Channel banks around bridge reinforced with large riprap. Opening is adequate. (08/23) Channel banks around bridge reinforced with large riprap. Opening is adequate. (02/22) (08/20)

Document Name: IMG_4519.JPG
 Category: Channel
 Span Number:
 Comments: South channel

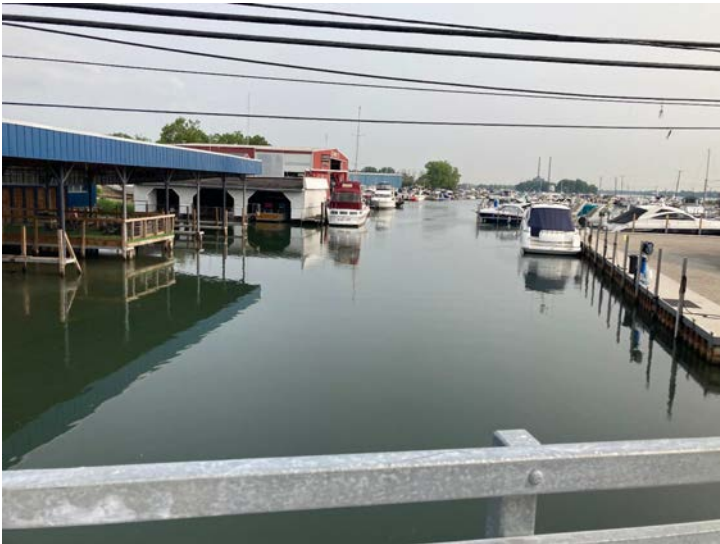
Document Name: IMG_4522.JPG
 Category: Channel
 Span Number:
 Comments: North channel
