MICHIGAN DEPARTMENT OF TRANSPORTATION

STR 12495

BRIDGE SAFETY INSPECTION REPORT

Facility HORSE ISLAND DRIVE	Latitude / Longitude 42.0867 / -83.1861	MDOT Structure ID 825263600015B01	Structure Condition Poor Condition(4)
Feature HORSE ISL & ADAMS DR BYU	Length / Width / Spans 45.9 / 23 / 1	Owner City: GIBRALTAR(2636)	
Location EAST OF ADAMS	Built / Recon. / Paint / Ovly. 1925 / / / 1999	TSC Taylor(25)	Operational Status P Posted for load(081216)
Region / County Metro(7) / Wayne(82)	Material / Design 1 Concrete / 11 Arch- Deck, Filled Sp	Last NBI Inspection 08/02/2023 / IDAM	Scour Evaluation 7 Countermeasures

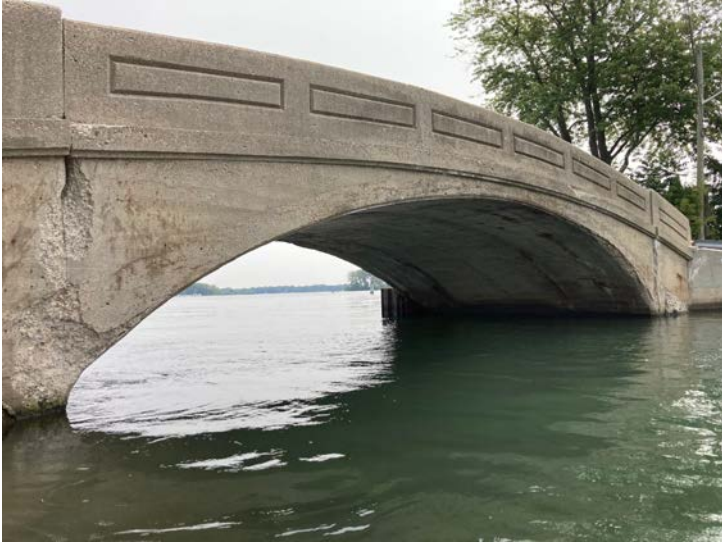
Document Name: IMG_4583.JPG
 Category: Elevation
 Span Number:
 Comments: South elevation

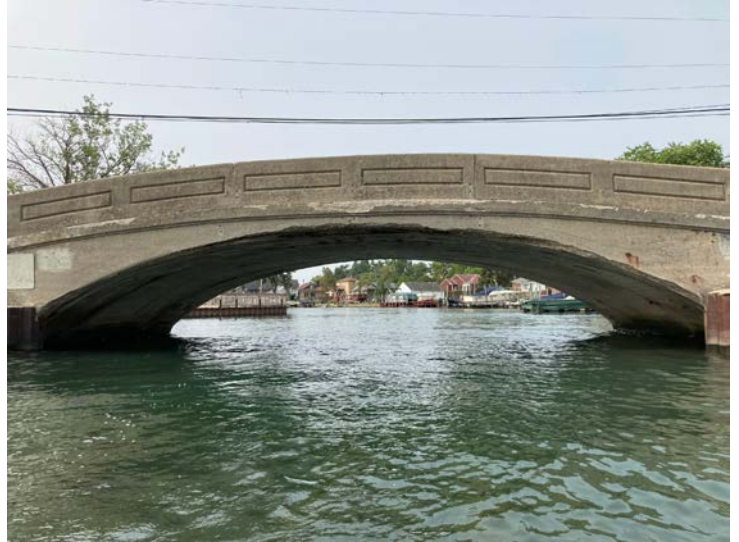
Document Name: IMG_4585.JPG
 Category: Elevation
 Span Number:
 Comments: North elevation

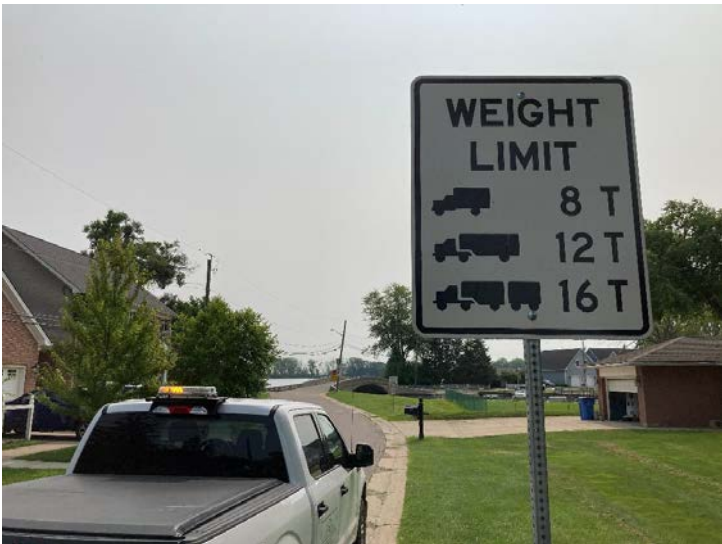
Document Name: IMG_4571.JPG
 Category: Posting
 Span Number:
 Comments: EB advanced load posting

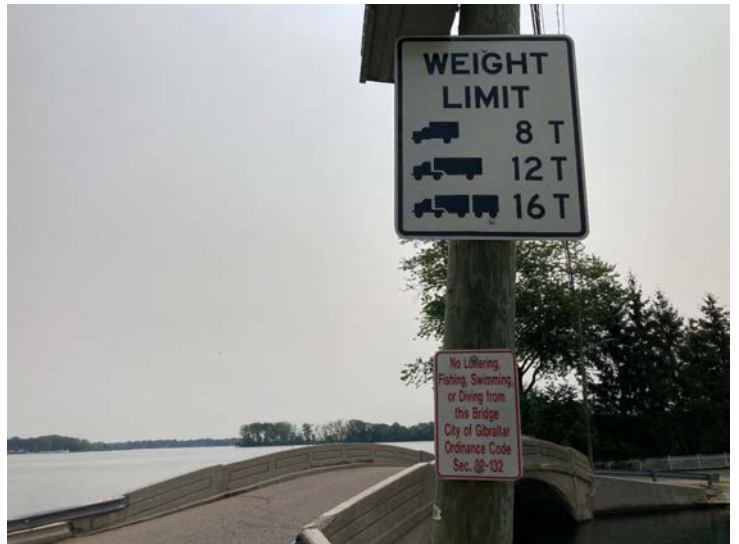
Document Name: IMG_4572.JPG
 Category: Posting
 Span Number:
 Comments: EB load posting

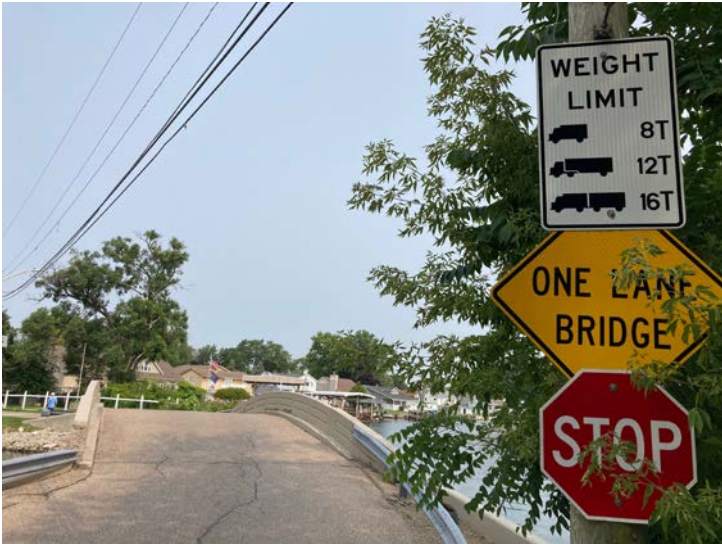
Document Name: IMG_4573.JPG
 Category: Posting
 Span Number:
 Comments: WB load posting

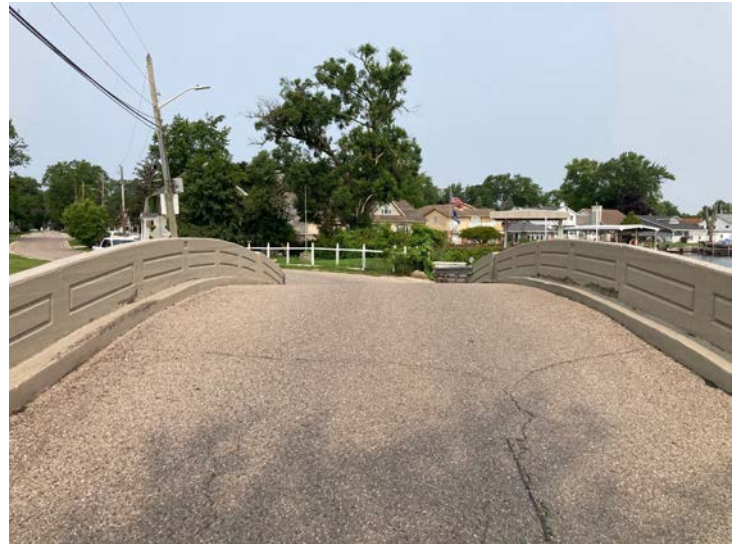
Document Name: IMG_4574.JPG
 Category: Approach
 Span Number:
 Comments: Looking west through structure

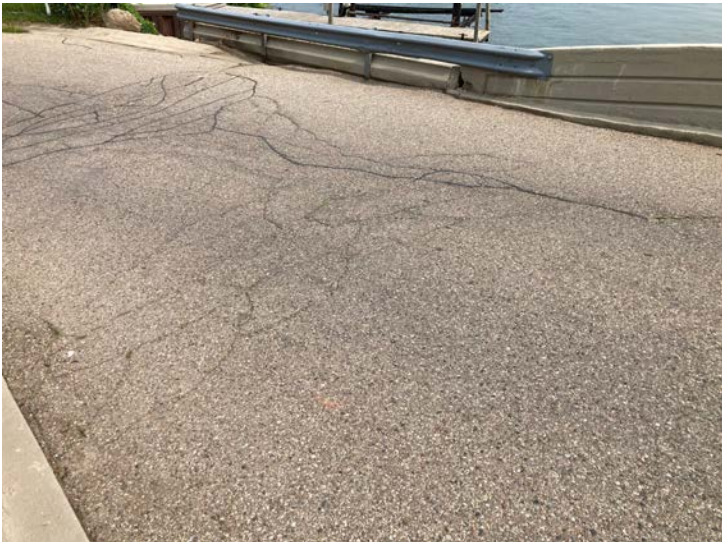
08/21	08/22	08/23	
18. Approach Pavement	6	6	6	Bit approaches have several sealed cracks, sealant starting to fail with vegetation growth. Alligator cracks in center of west approach. (08/23) Bit approaches have several sealed cracks, sealant starting to fail with vegetation growth. Alligator cracks in center of west approach. (08/22) Bit approaches have several sealed cracks, sealant starting to fail. Alligator cracks in center of west approach. (08/21)

Document Name: IMG_4575.JPG
 Category: Approach
 Span Number:
 Comments: West approach

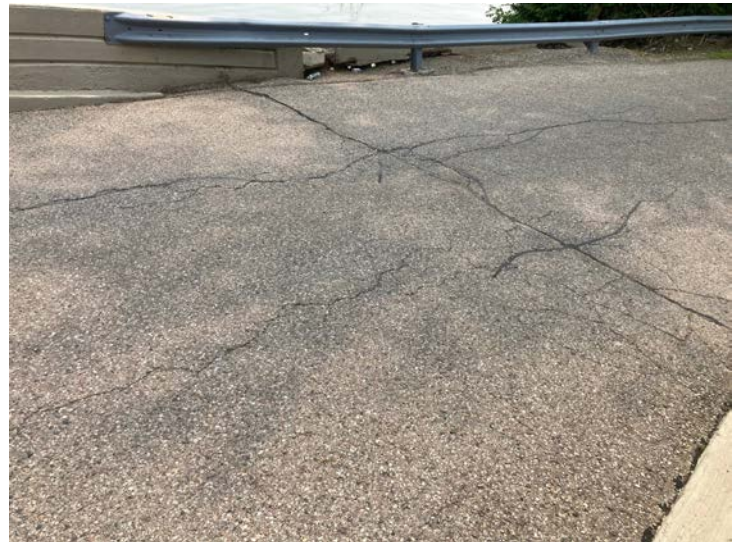
Document Name: IMG_4577.JPG
 Category: Approach
 Span Number:
 Comments: East approach

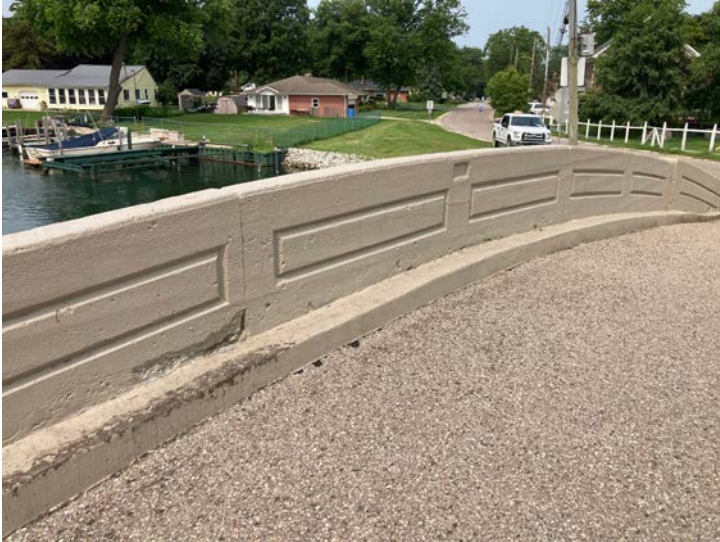
2. Expansion Joints	N	N	N	(08/23) (08/22) (08/21)
3. Other Joints	N	N	N	(08/23) (08/22) (08/21)
4. Railings	5	5	5	Solid concrete parapets with brushblocks and concrete surface coating. Spalls at the bottom of the parapets on inside of railing. West and east end of south railing is spalled with approach guardrail no longer connected. North: offset at midspan 1/2" ; spall in NW. (08/23) Solid concrete parapets with brushblocks and concrete surface coating. Spalls at the bottom of the parapets on inside of railing. West and east end of south railing is spalled with approach guardrail no longer connected. North: offset at midspan; spall in NW. (08/22) Solid concrete parapets with brushblocks and concrete surface coating. Spalls at the bottom of the parapets on inside of railing. West end of south railing is spalled with approach guardrail no longer connected. (08/21)

Document Name: IMG_4578.JPG
 Category: Railing
 Span Number:
 Comments: South rail

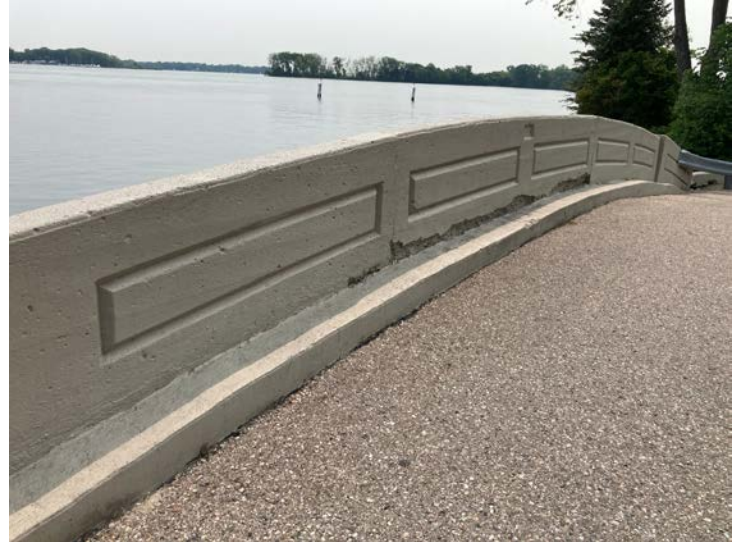
Document Name: IMG_4580.JPG
 Category: Railing
 Span Number:
 Comments: North rail

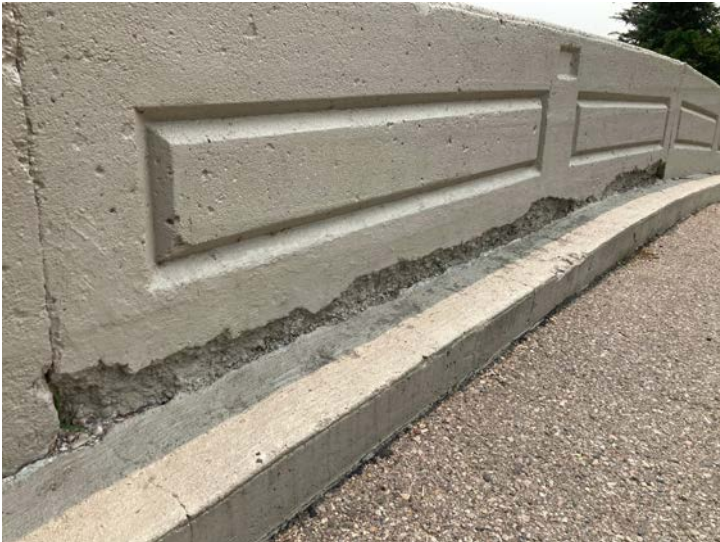
Document Name: IMG_4582.JPG
 Category: Railing
 Span Number:
 Comments: Spalling in rails

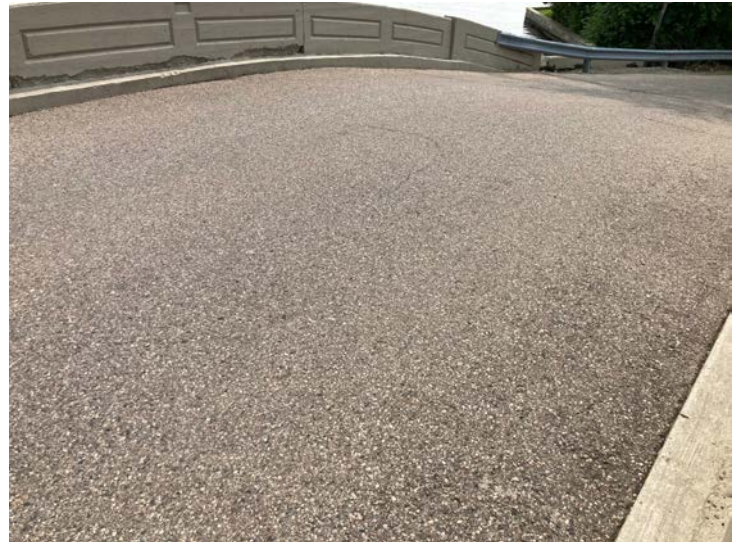
08/21	08/22	08/23	
1. Surface (SIA-58A)	7	7	7	HMA surface. There are two transverse and two longitudinal cracks along east 1/2. Random cracking at midspan. (08/23) HMA surface. There are two transverse and two longitudinal cracks along east 1/2. Random cracking , midspan. (08/22) HMA surface. There are two transverse and two longitudinal cracks. (08/21)

Document Name: IMG_4576.JPG
 Category: Deck
 Span Number:
 Comments: HMA surface

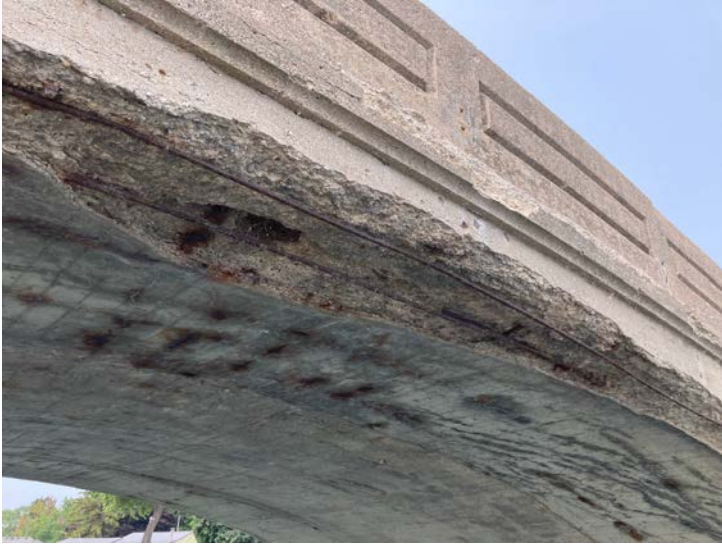
9. Stringer (SIA-59)	4	4	4	<p>Earth filled arch. The bottom edge of south fascia is spalled from the east 1/4-pt to the east abutment measuring up to 6" wide with up to 2" penetration. Spall along bottom edge of north fascia for full length (2.5 ft. wide, 6 in. pen, 2 debonded bars). Concrete on underside of arch has longitudinal hairline to 1/8" cracks extending the entire span with efflorescence and rust staining as well as isolated areas of delamination and spalling with exposed reinforcing steel. Cracks at the segment joints along the entire length of the span measuring 1/8" - 1/4" wide with associated spalling up to 1' wide with up to 2" penetration and exposed corroded reinforcing steel. Estimate 25-35% of bottom cracked/delaminated/spalled. Soffit: incipient spall at mispan, along joint 1s. (08/23)</p> <p>Earth filled arch. There are two spalls on bottom edge of south fascia from the east 1/4-pt to the east abutment measuring up to 6" wide with up to 2" penetration. Spall along bottom edge of north fascia from the east 1/4-pt. to the west abutment (2.5 ft. wide, 6 in. pen, 2 debonded bars). Concrete on underside of arch has longitudinal hairline to 1/8" cracks extending the entire span with efflorescence and rust staining as well as isolated areas of delamination and spalling with exposed reinforcing steel. Cracks at the segment joints along the entire length of the span measuring 1/8" - 1/4" wide with associated spalling up to 1' wide with up to 2" penetration and exposed corroded reinforcing steel. Estimate 25-35% of bottom cracked/delaminated/spalled. Soffit: incipient spall at mispan, along joint 1s. (08/22)</p> <p>Earth filled arch. There are two spalls on bottom edge of south fascia from the east 1/4-pt to the east abutment measuring up to 6" wide with up to 2 in. pen. Spall along bottom edge of north fascia from the east 1/4-pt. to the west abutment (2.5 ft. wide, 6 in. pen, 2 debonded bars). Concrete on underside of arch has longitudinal hairline to 1/8 in. cracks extending the entire span with efflorescence and rust staining as well as random areas of delamination and spalling with exposed reinforcing steel. Cracks at the segment joints along the entire length of the span measuring 1/8 - 1/4 in. wide with associated spalling up to 1 ft. wide with up to 2 in. pen. and exposed corroded reinforcing steel. Estimate 25-35% of bottom cracked/delaminated/spalled. (08/21)</p>

Document Name: IMG_4584.JPG
 Category: Superstructure
 Span Number:
 Comments: Spall to steel with 2 debonded bars along north fascia.

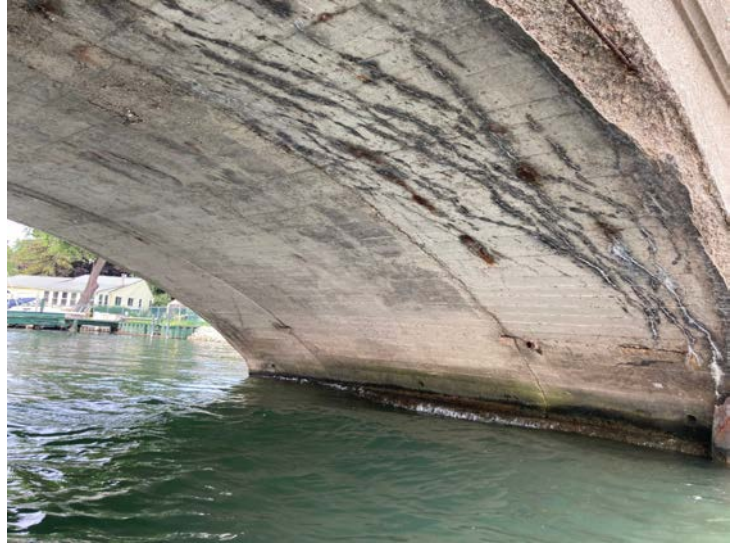
Document Name: IMG_4586.JPG
 Category: Superstructure
 Span Number:
 Comments: West half of arch

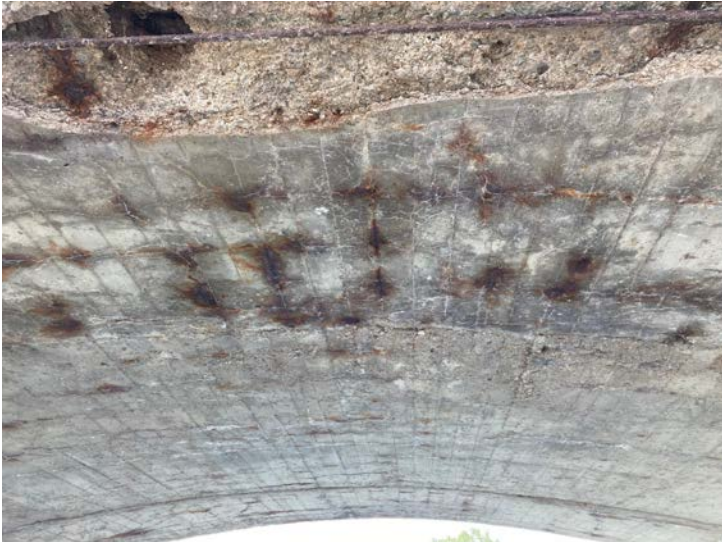
Document Name: IMG_4587.JPG
 Category: Superstructure
 Span Number:
 Comments: Top of arch

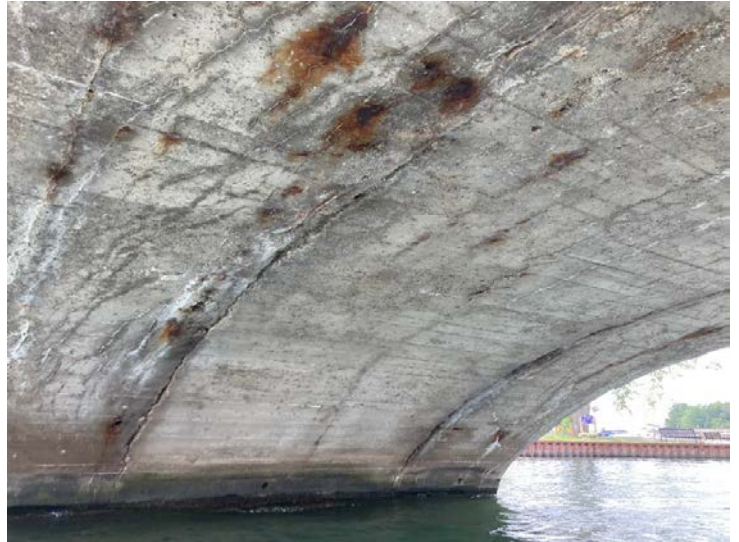
Document Name: IMG_4588.JPG
 Category: Superstructure
 Span Number:
 Comments: East half of arch

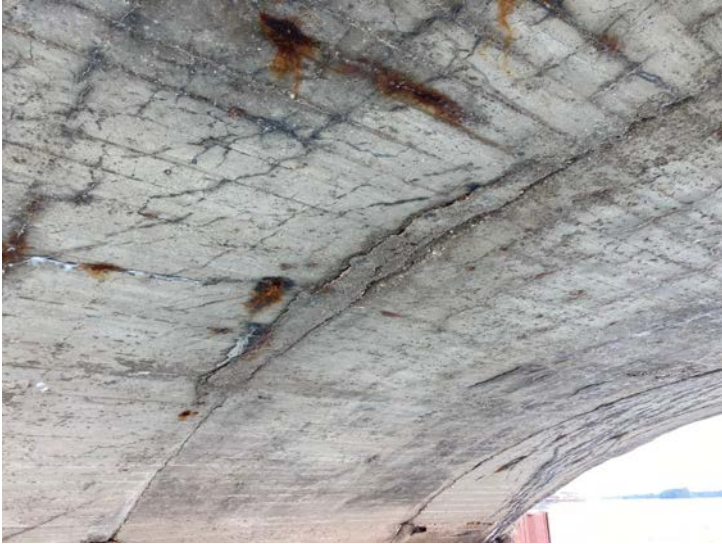
Document Name: IMG_4589.JPG
 Category: Superstructure
 Span Number:
 Comments: Incipient spall along construction joint

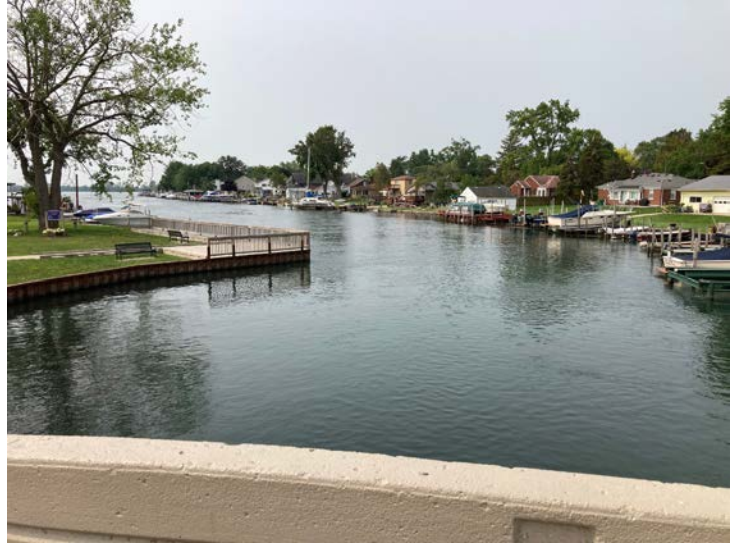
15. Slope Protection	N	N	N	(08/23) (08/22) (08/21)
16. Channel (SIA-61)	6	6	6	Flow north to south. Channel is open. Retaining walls are in good condition. Undermining along grout bags at both abutments. (08/23) Channel is open. Retaining walls are in good condition. Undermining along grout bags at both abutments. (08/22) Channel is open. Retaining walls are in good condition. Undermining along grout bags at both abutments. (08/21)

Document Name: IMG_4579.JPG
 Category: Channel
 Span Number:
 Comments: South channel

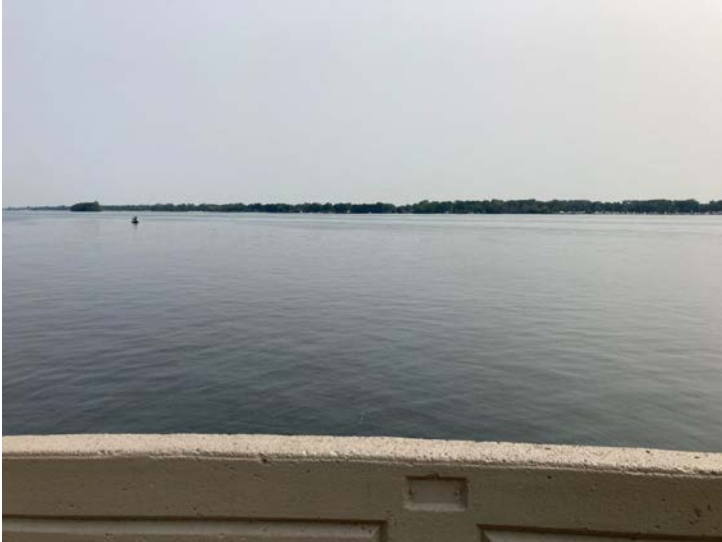
Document Name: IMG_4581.JPG
 Category: Channel
 Span Number:
 Comments: North channel
