MICHIGAN DEPARTMENT OF TRANSPORTATION

STR 12496

BRIDGE SAFETY INSPECTION REPORT

Facility YOUNG DRIVE	Latitude / Longitude 42.0857 / -83.196	MDOT Structure ID 825263600020B01	Structure Condition Poor Condition(4)
Feature W GIBRALTAR WATERWAY	Length / Width / Spans 77.1 / 31.2 / 2	Owner City: GIBRALTAR(2636)	
Location EAST OF WORTH	Built / Recon. / Paint / Ovly. 1990 / / /	TSC Taylor(25)	Operational Status P Posted for load(081216)
Region / County Metro(7) / Wayne(82)	Material / Design 5 Prestressed Concrete / 05 Box Bm/Gird- Multiple	Last NBI Inspection 08/02/2023 / Q11J	Scour Evaluation 3 SC - Unstable

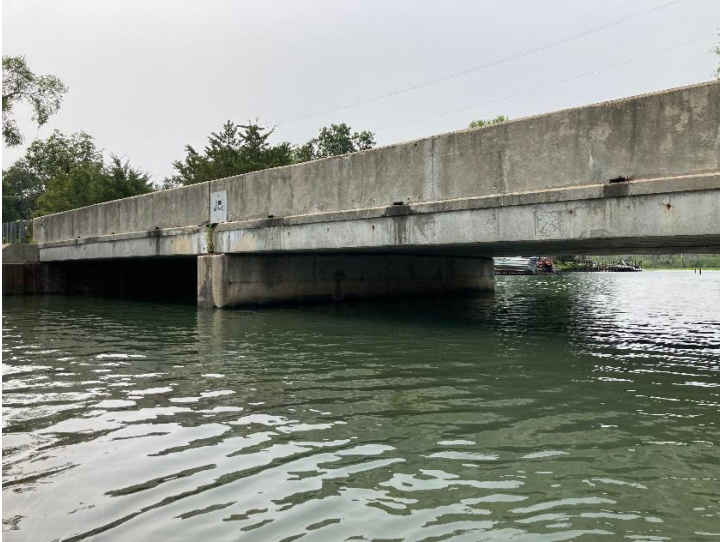
Document Name: IMG_4606.JPG
 Category: Elevation
 Span Number:
 Comments: North elevation

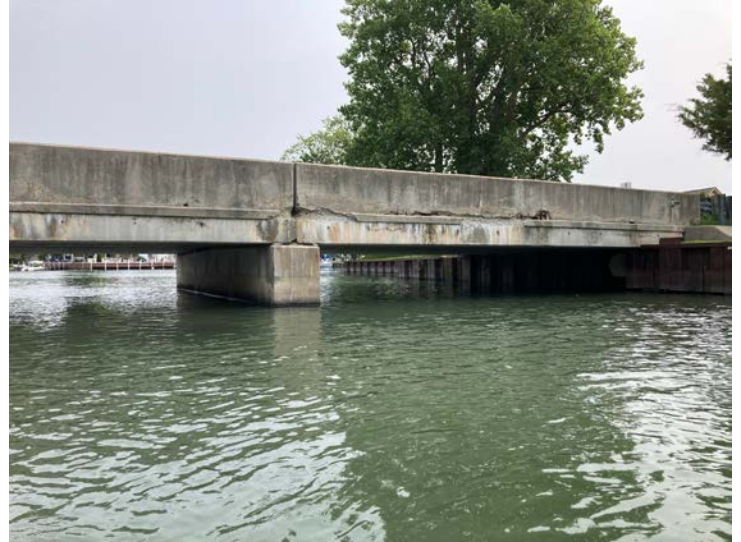
Document Name: IMG_4610.JPG
 Category: Elevation
 Span Number:
 Comments: South elevation

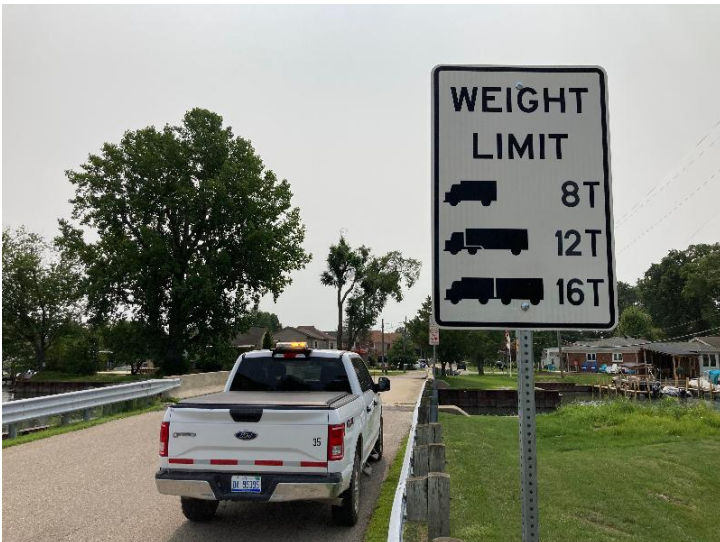
Document Name: IMG_4591.JPG
 Category: Posting
 Span Number:
 Comments: EB load posting

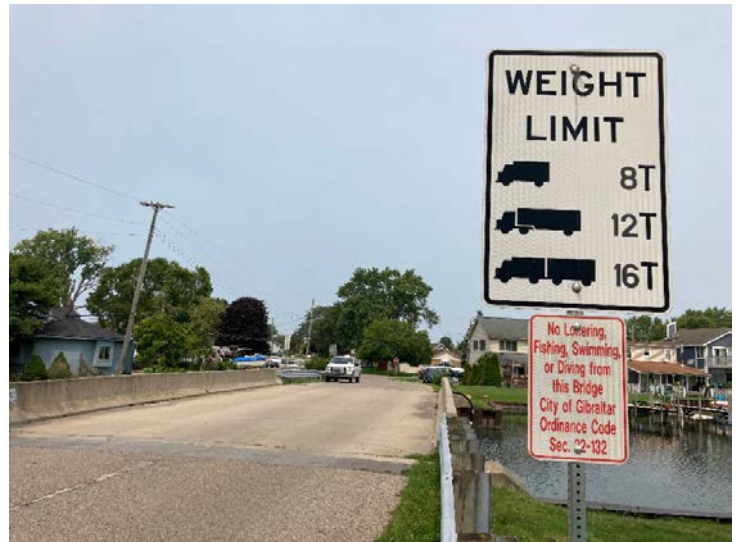
Document Name: IMG_4592.JPG
 Category: Posting
 Span Number:
 Comments: WB load posting

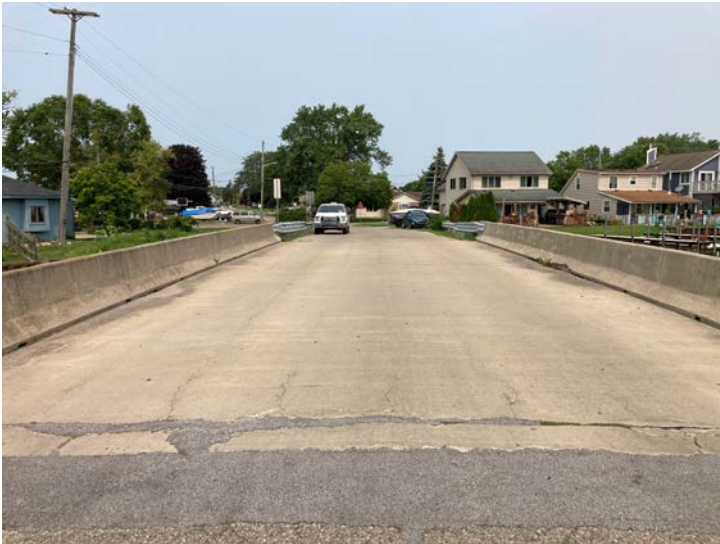
Document Name: IMG_4593.JPG
 Category: Approach
 Span Number:
 Comments: Looking west through structure

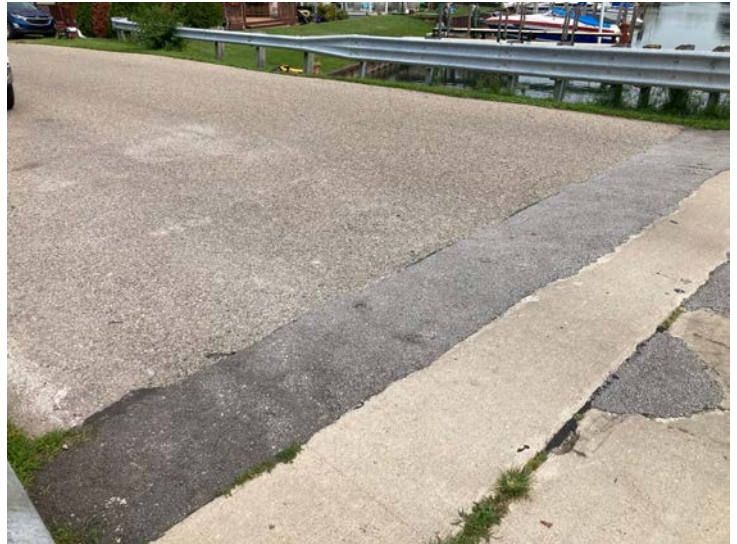
18. Approach Pavement	4	4	4	Bit approaches. Both approaches have been wedged several times. Settlement estimated at 3"-5" with impact loading at reference lines. East: bit spalled along centerline. West: Isolated longitudinal cracking. (08/23) Bit approaches. Both approaches have been wedged several times. Settlement estimated at 3"-5" with impact loading at reference lines. East: bit spalled along centerline. West: Isolated longitudinal cracking. (08/22) Bit approaches. Both approaches have been wedged several times. Settlement estimated at 3"-5" with impact loading at reference lines. (08/21)

Document Name: IMG_4594.JPG
 Category: Approach
 Span Number:
 Comments: West approach

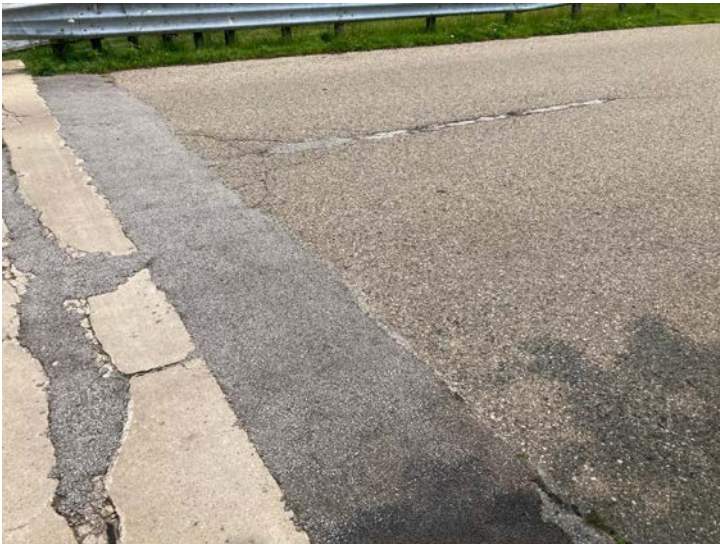
Document Name: IMG_4600.JPG
 Category: Approach
 Span Number:
 Comments: East approach

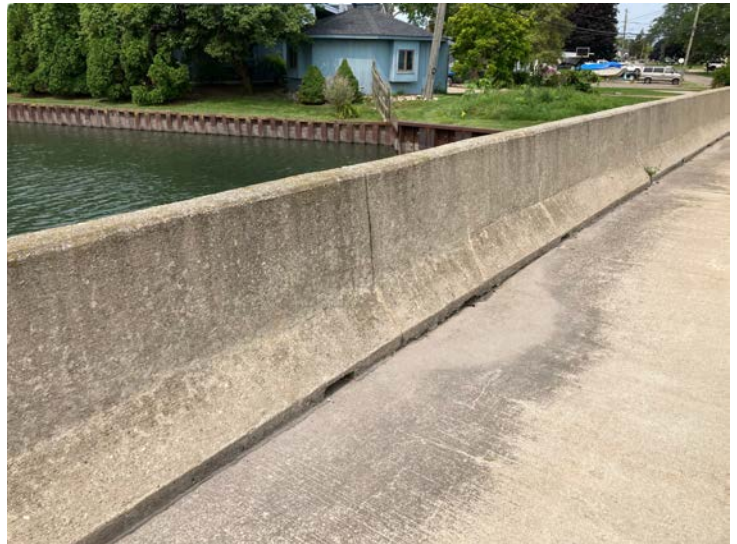
4. Railings	6	6	6	Type 4 railing has vertical leaching cracks at 3' to 5' spacing. Spalls at botom of north railing at pier and east abutment. 12 sft spall in south side of south rail. (08/23) Type 4 railing has vertical leaching cracks at 3' to 5' spacing. Spalls at botom of north railing at pier and east abutment. (08/22) Type 4 railing has vertical cracks at 3' to 5' spacing. Spalls at botom of north railing at pier and east abutment. (08/21)

Document Name: IMG_4601.JPG
 Category: Railing
 Span Number:
 Comments: South rail

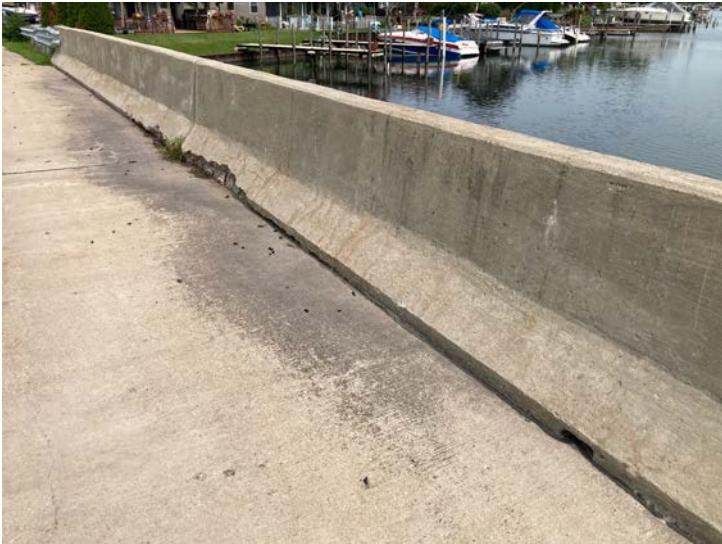
Document Name: IMG_4603.JPG
 Category: Railing
 Span Number:
 Comments: North rail

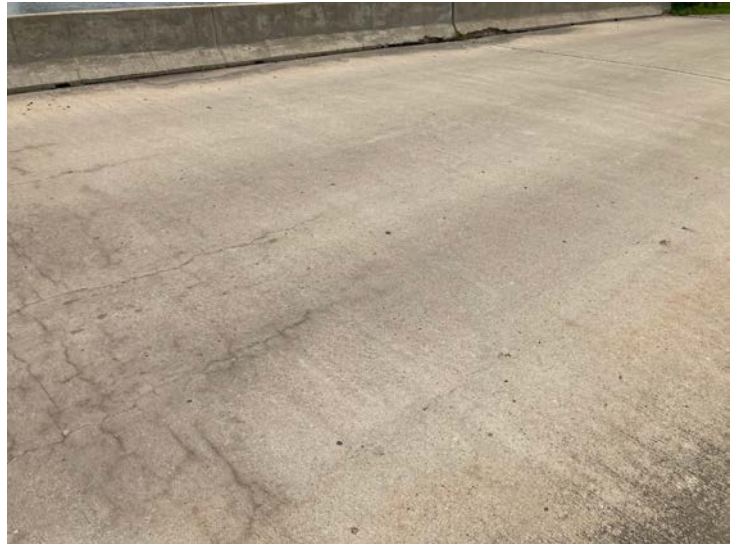
Document Name: IMG_4596.JPG
 Category: Deck
 Span Number:
 Comments: Deck surface span 1w

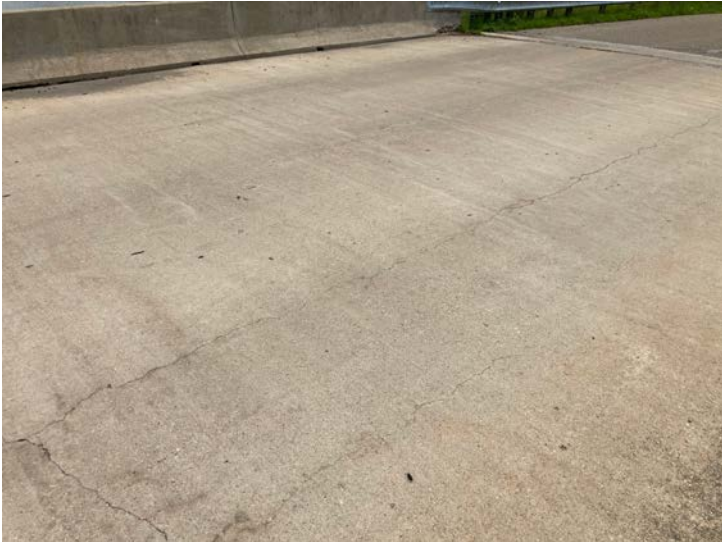
Document Name: IMG_4598.JPG
 Category: Deck
 Span Number:
 Comments: Deck surface, span 2w

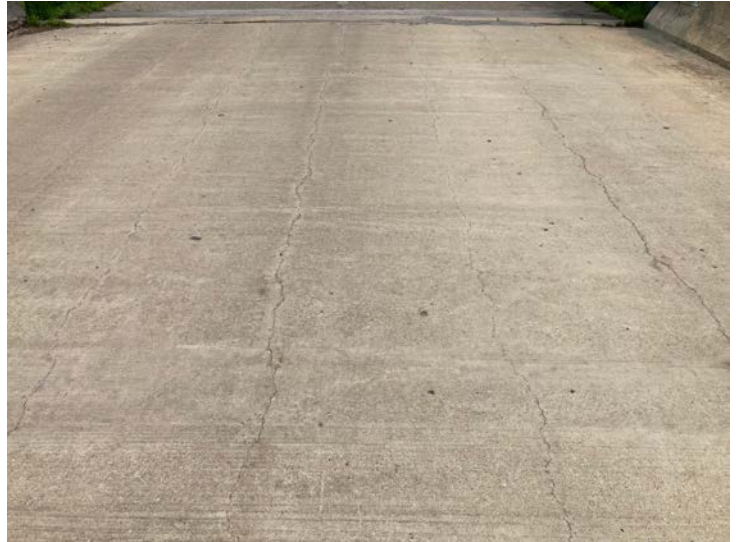
08/21	08/22	08/23	
1. Surface (SIA-58A)	6	6	6	Concrete deck. Open beam line cracks along full length with some transverse cracks. At west reference line, approx 12sft spall/HMA patch. Delamination noted at joints. Open block cracking near joint 1w. East: several bit patches at reference line. (08/23) Concrete deck. Open beam line cracks along full length. At west reference line, approx 12sft spall/HMA patch. Delamination noted at joints. Open block cracking near joint 1w. East: several bit patches at reference line. (08/22) Concrete deck. Open beam line cracks along full length. At west reference line, approx 8sft spall/HMA patch. Delamination noted at joints. (08/21)

Document Name: IMG_4605.JPG
 Category: Deck
 Span Number:
 Comments: Longitudinal cracks in deck surface

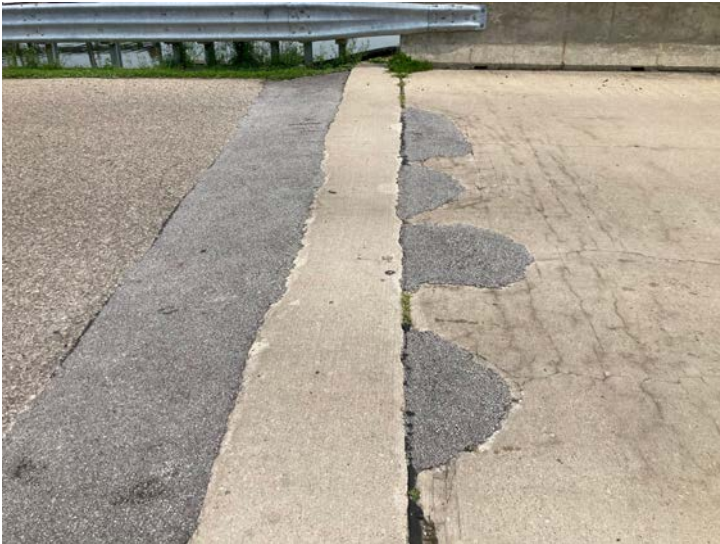
3. Other Joints	4	4	4	Pourable joints at abutment reference lines. Spalled and bit patched over 75% of length with veg growth. Leakage noted below. (08/23) Pourable joints at abutment reference lines. Spalled and bit patched over 50% of length. Leakage noted below. (08/22) Pourable joints at abutment reference lines. Spalled and bit patched over 50% of length. Leakage noted below. (08/21)

Document Name: IMG_4595.JPG
 Category: Joints
 Span Number:
 Comments: West reference line

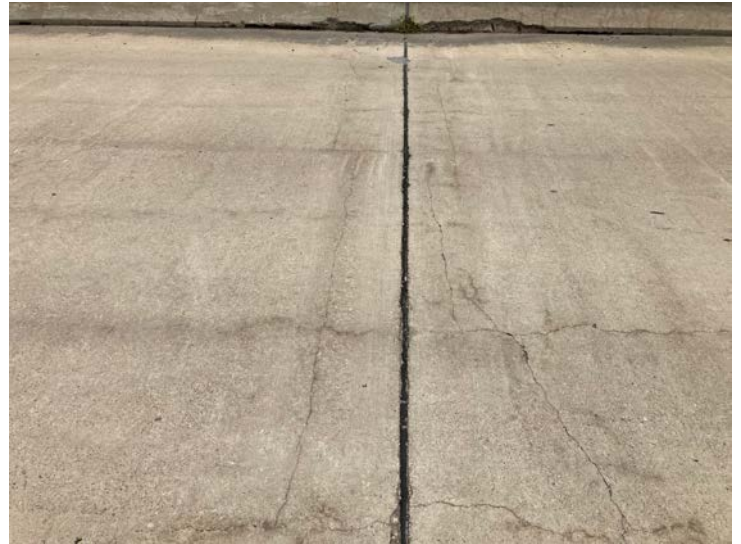
2. Expansion Joints	4	4	4	Pourable joint at pier is debris filled, 80% loss of adhesion. There is a 1 sft bit spall at the joint. (08/23) Pourable joint at pier is debris filled, 80% loss of adhesion. There is a 1 sft bit spall at the joint. (08/22) Pourable joints at pier is debris filled. There is a 1 sft spall at the joint. (08/21)

Document Name: IMG_4597.JPG
 Category: Joints
 Span Number:
 Comments: Joint 1w

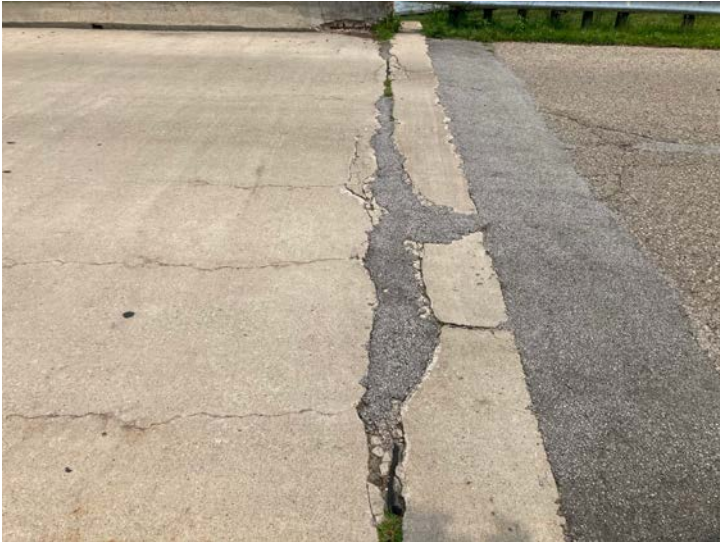
Document Name: IMG_4599.JPG
 Category: Joints
 Span Number:
 Comments: east reference line

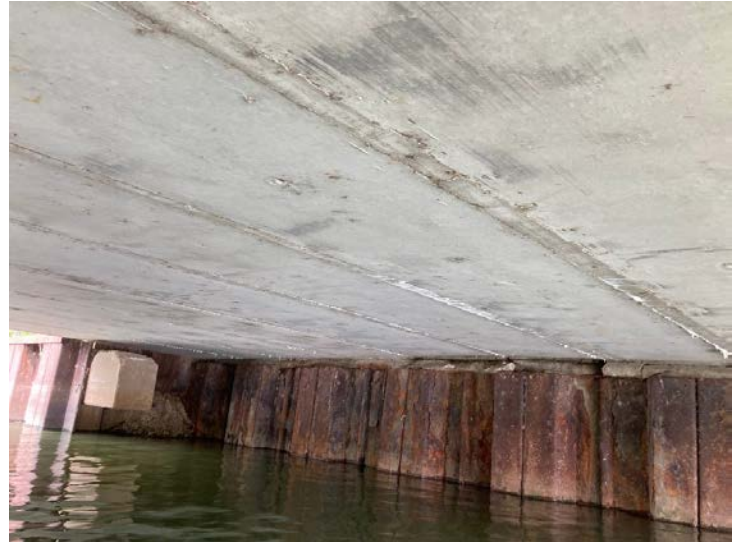
5. Sidewalks or Curbs	N	N	N	(08/23) (08/22) (08/21)
6. Deck Bottom Surface (SIA-58B)	N	N	N	Adjacent box beams .Leakage with efflorescence at all west abutment joints and few joints at pier and east abutment. (08/23) Adjacent box beams. (08/22) Adjacent box beams. (08/21)

Document Name: IMG_4609.JPG
 Category: Superstructure
 Span Number:
 Comments: Leakage at beams

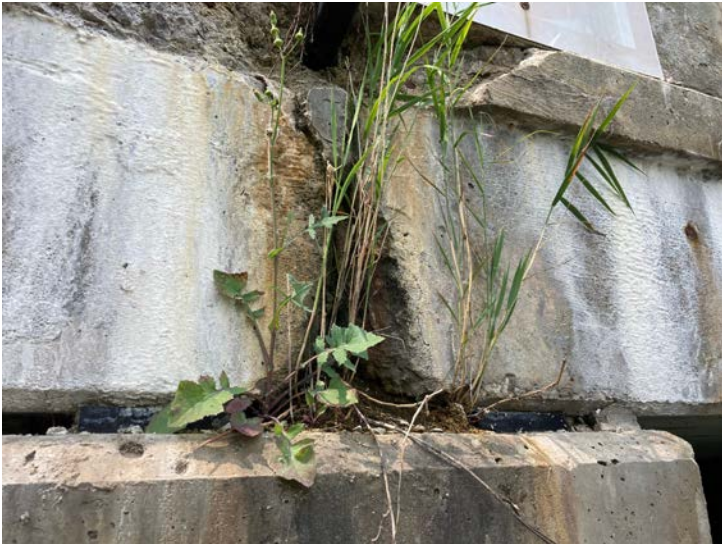
08/21	08/22	08/23	
9. Stringer (SIA-59)	5	5	5	<p>10 (EA) Adjacent box beams. Beam ends have spalls at pier; beam 10s STS with 1 exposed stirrup. Areas of rust staining, 1 in. dia, on the north fascia box beams and south fascia box beams, approx 9 per beam. Hairline horizontal cracks over 30% of length of south fascia in span 2w. South fascia, span 2w has a 1sft STS. Several joints leaching with stalactites along all west abutment joints and few joints at pier and east abutment. (08/23)</p> <p>Adjacent box beams. Beam ends have spalls at pier; beam 10s STS with 1 exposed stirrup. Areas of rust staining, 1 in. dia, on the north fascia box beams and south fascia box beams, approx 9 per beam. Hairline horizontal cracks over 30% of length of south fascia in east span. South fascia, east span has a 1sft STS. There is some efflorescence between beams. Several joints leaching with stalactites, all near west abutment. (08/22)</p> <p>Adjacent box beams. Beam ends have spalls at pier with no exposed stirrups. Areas of rust staining, 1 in. dia, on the north fascia box beams and south fascia box beams, approx 9 per beam. Hairline horizontal cracks over 30% of length of south fascia in east span. South fascia, east span has a 1sft STS. There is some efflorescence between beams. (08/21)</p>

10. Paint (SIA-59A)	N	N	N	<p>(08/23)</p> <p>(08/22)</p> <p>(08/21)</p>
11. Section Loss	2	2	2	<p>Spalls at beam end at piers with 1 exposed stirrups. (08/23)</p> <p>Spalls at beam ends at piers with no exposed stirrups. (08/22)</p> <p>Spalls at beam ends at piers with no exposed stirrups. (08/21)</p>

Document Name: IMG_4612.JPG
 Category: Superstructure
 Span Number:
 Comments: Spall to steel in beam 10s

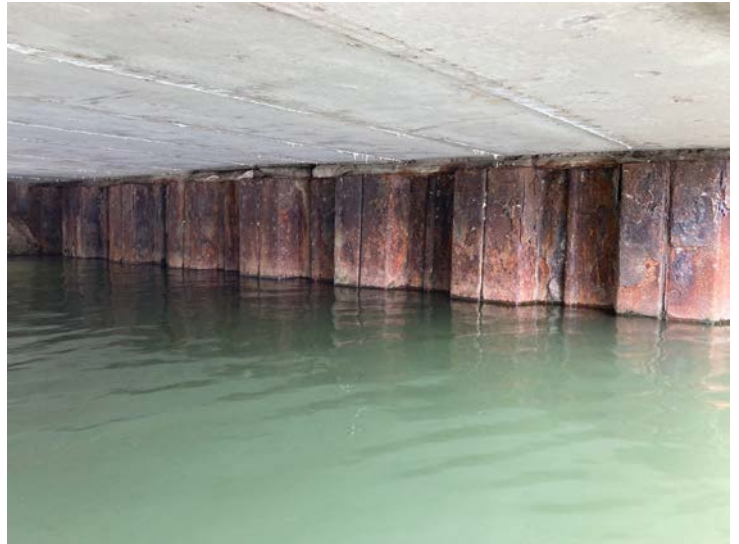
13. Abutments (SIA-60)	4	5	5	<p>Concrete cap on steel H-pile with steel sheet piling. Abutments are pile supported however the sheeting does support the backfill behind the abutment and below the approach pavement. Sheeting is rusty with heavy scale, worse at concrete interface. West abutment: heavy rust/scale and pitting in steel sheet piling, no holes present. East abutment: heavy scale in sheet piling. Riprap lining the abutment. Rating based on condition of steel sheet pile. (08/23)</p> <p>Concrete cap on steel H-pile with steel sheet piling. Abutments are pile supported however the sheeting does support the backfill behind the abutment and below the approach pavement. Sheeting is rusty with heavy scale, worse at concrete interface. West abutment: heavy rust/scale and pitting in steel sheet piling, no holes present. East abutment: heavy scale in sheet piling. Riprap lining the abutment. Rating based on condition of steel sheet pile. (08/22)</p> <p>Concrete cap on steel sheet pile. Sheeting is rusty with heavy scale, worse at concrete interface. Heavy pitting, but no holes found. (08/21)</p>

Document Name: IMG_4607.JPG
 Category: Substructure
 Span Number:
 Comments: West abutment

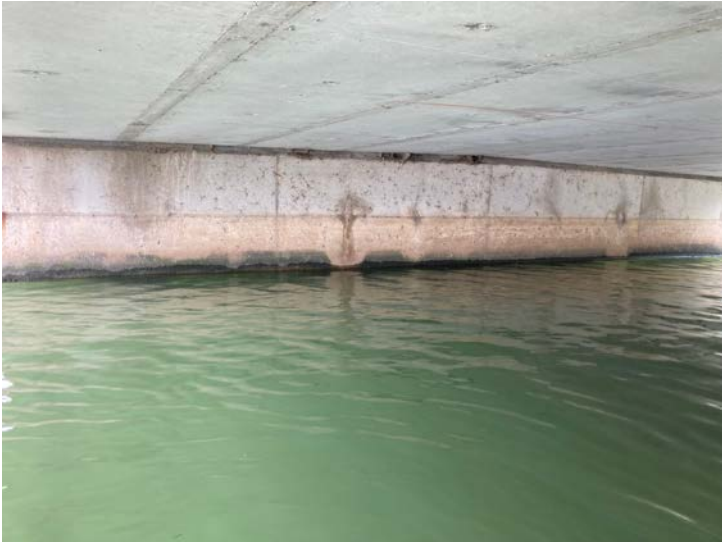
14. Piers (SIA-60)	4	4	4	<p>Concrete cap on pile bent. H Pile covered with corrugated steel pipe and filled with concrete. Water level high , only concrete cap is visible during routine inspection. UW report notes: Corrugated steel pile shells have 100% section loss in various areas. Concrete pile encasement has spalling with exposed H piles in various locations. Scaling near the waterline on pile cap. (08/23)</p> <p>Concrete cap on pile bent. H Pile covered with corrugated steel pipe and filled with concrete. Water level high, previous inspection noted: Steel pipe is heavily corroded with holes, worse at top of encasement. Concrete fill is spalled with pile visible at several locations. Only concrete cap is visible during routine inspection. Pier 1w: Steel encasement heavily corroded. Concrete visible through steel encasement, with areas of spalling. Steel H-pile visible in several locations. (08/22)</p> <p>Concrete cap on pile bent. H Pile covered with corrugated steel pipe and filled with concrete. Steel pipe is heavily corroded with holes, worse at top of encasement. Concrete fill is spalled with pile visible at several locations. Only concrete cap is visible during routine inspection. (08/21)</p>

Document Name: IMG_4608.JPG
 Category: Substructure
 Span Number:
 Comments: Pier 1w

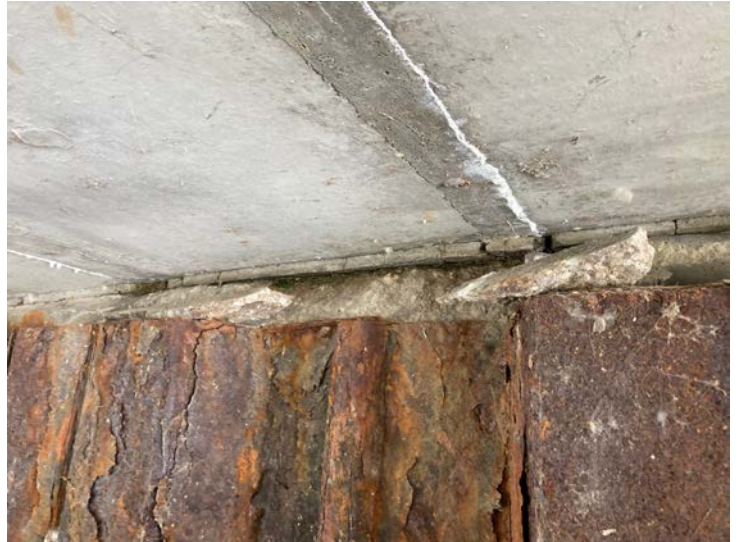
Document Name: IMG_4611.JPG
 Category: Substructure
 Span Number:
 Comments: Spalling of concrete at top of abutments

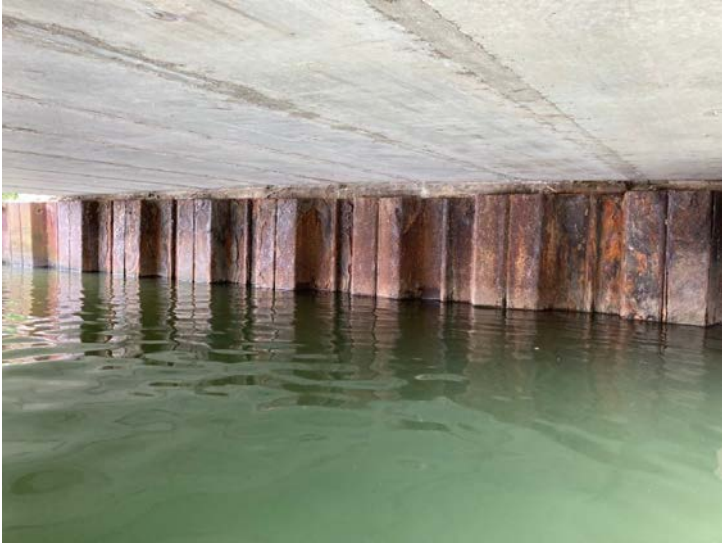
Document Name: IMG_4613.JPG
 Category: Substructure
 Span Number:
 Comments: East abutment

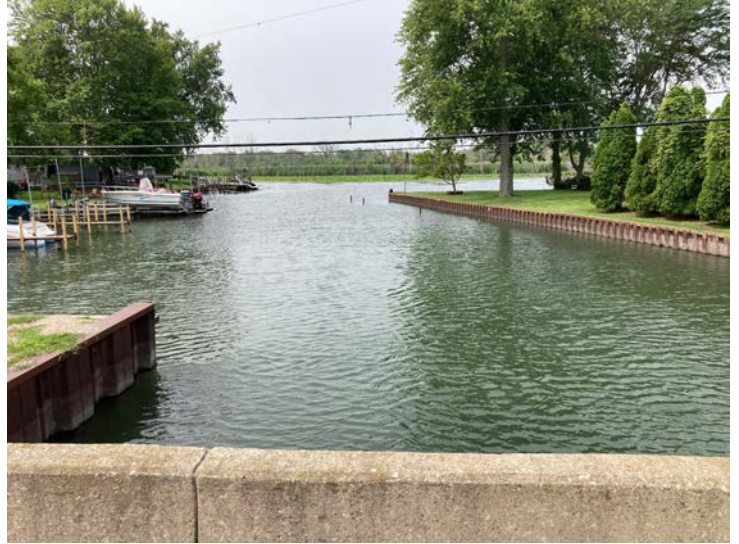
Document Name: IMG_4602.JPG
 Category: Channel
 Span Number:
 Comments: South channel

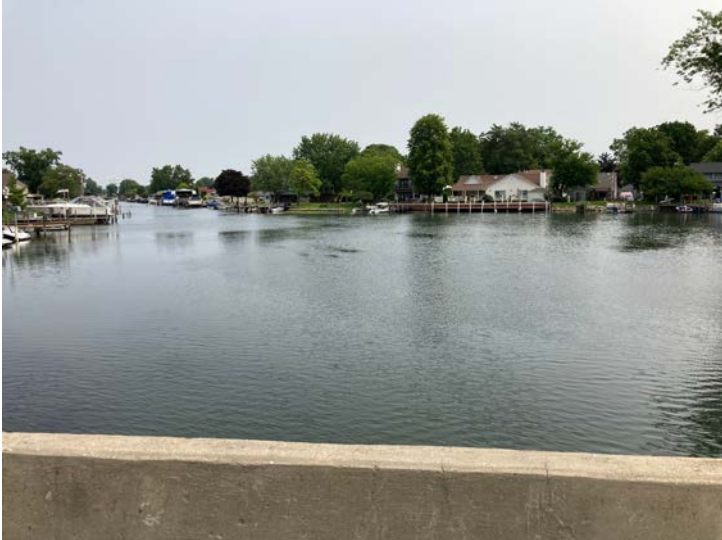
Document Name: IMG_4604.JPG
 Category: Channel
 Span Number:
 Comments: North channel
